### Assessment of Stream Restoration Structures in Streams of North-Central Pennsylvania

Report to the Cora Brooks Foundation

# Assessment of stream restoration structures in streams of north-central Pennsylvania

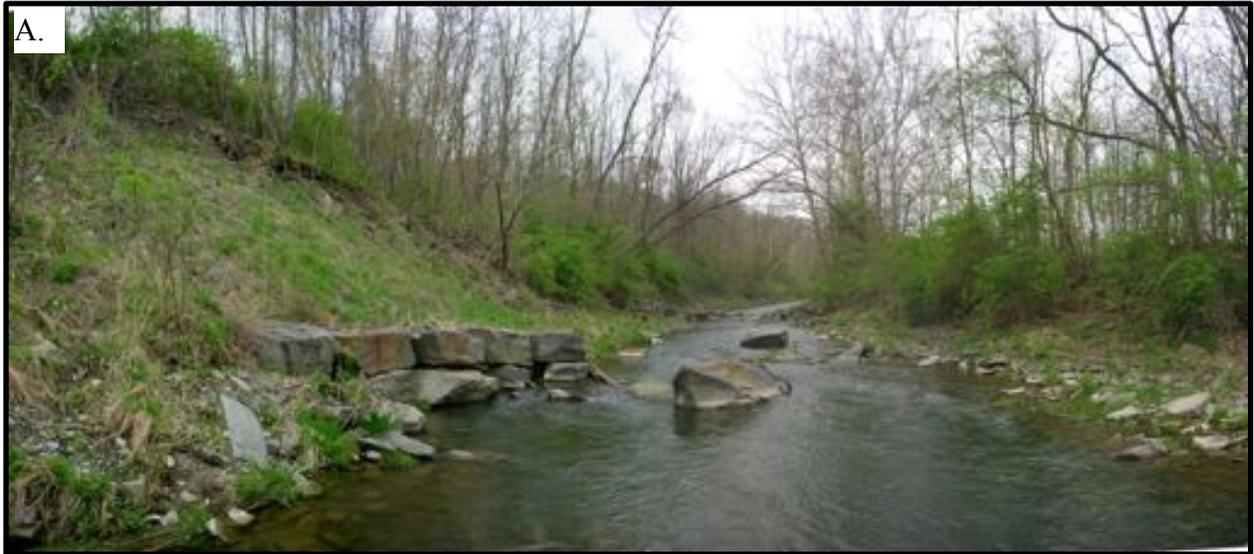
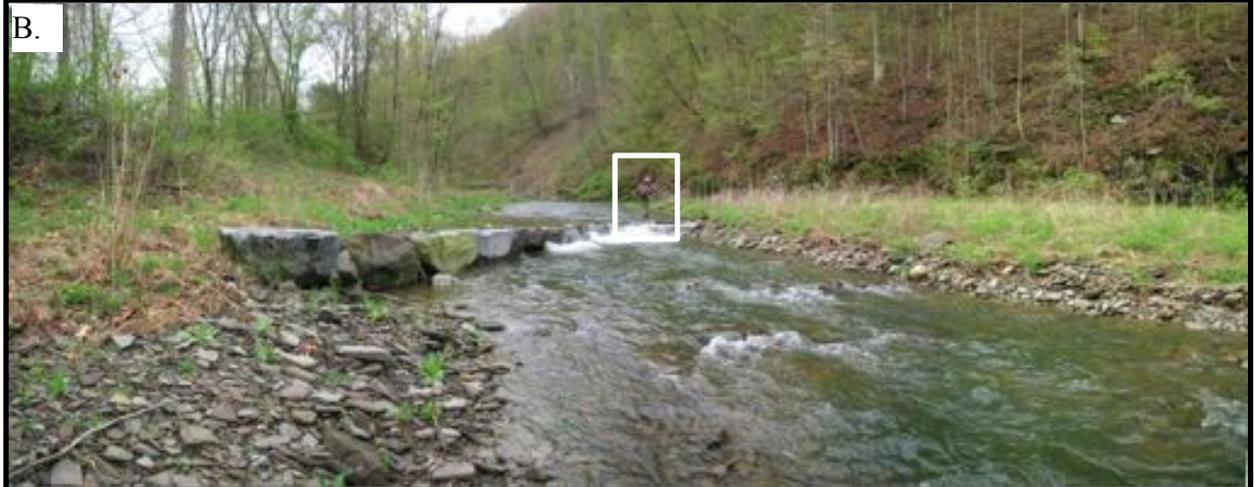
Even though over half of the structures are still functioning, many of them are being impacted by the deposition of gravel bars over the wings and throats of the structures (Figure 7b). Out of the structures with an integrity ranking of one or two, meaning that they are still functioning, 75% of them are impacted by deposition or erosion (a ranking of 2 or higher). Over 80% of all the structures, including those that are impaired or failing, have a deposition/erosion ranking of 2 or higher. This means that deposition over at least 25% of the structure has occurred, along with deposition in the pool and/or erosion is visible which will likely influence flow. In this stream, the majority of structures are impacted by deposition of gravel over the wings of the structure or in the pool downstream of the structure. The amount of gravel moving through the system is seen in aerial photographs from Google Earth (Figure 8).

**Figure 7.** A) Photograph from Site 2 showing an “impaired” structure. It is unknown if this is a rock vane and is just missing the boulders in the channel or if this was a j-hook or cross vane and is missing more boulders than could be seen. B) Photograph from Site 2 of a cross vane that is half buried by a major gravel bar along the left wing. The person in the white box is standing at the throat rocks of this structure. The left wing boulders were actually found buried in the gravel bar. Photographs by C. Kassab.

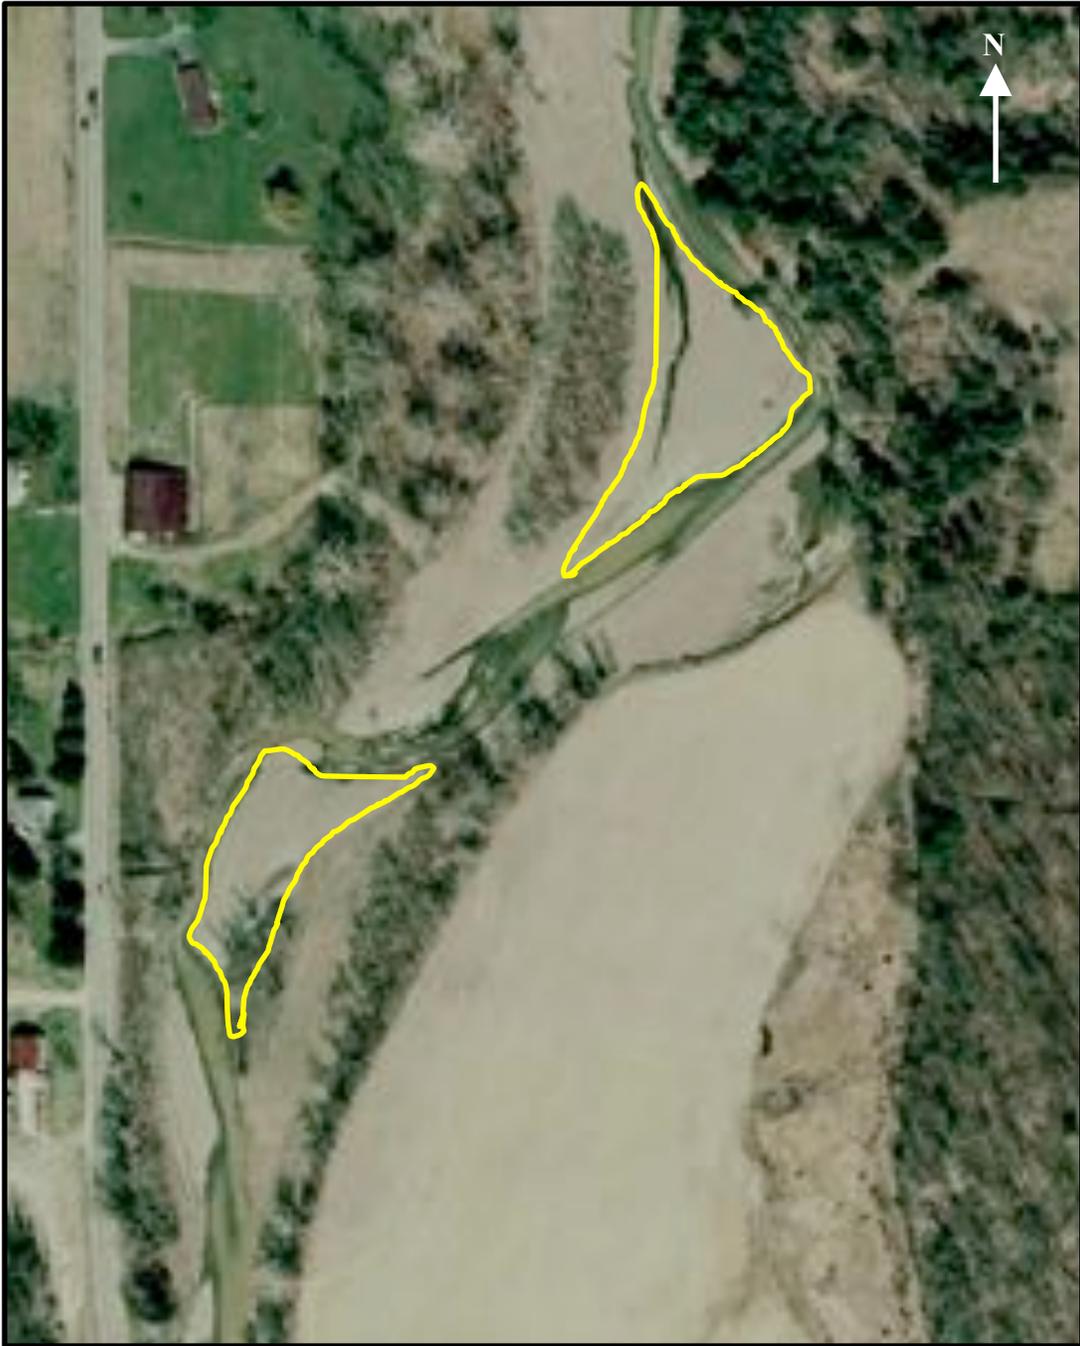
**Figure 8.** Aerial photograph from Google Earth of part of site 4 prior to the current configuration of the channel and current set of structures. Note the large gravel bars (highlighted in yellow) illustrating the large amount of gravel that is moving through this reach of the system. This amount of gravel is not found further upstream in the “restored” reaches. Now that the channel has been reconfigured to a more straighter reach, the large gravel bars are not as prevalent.

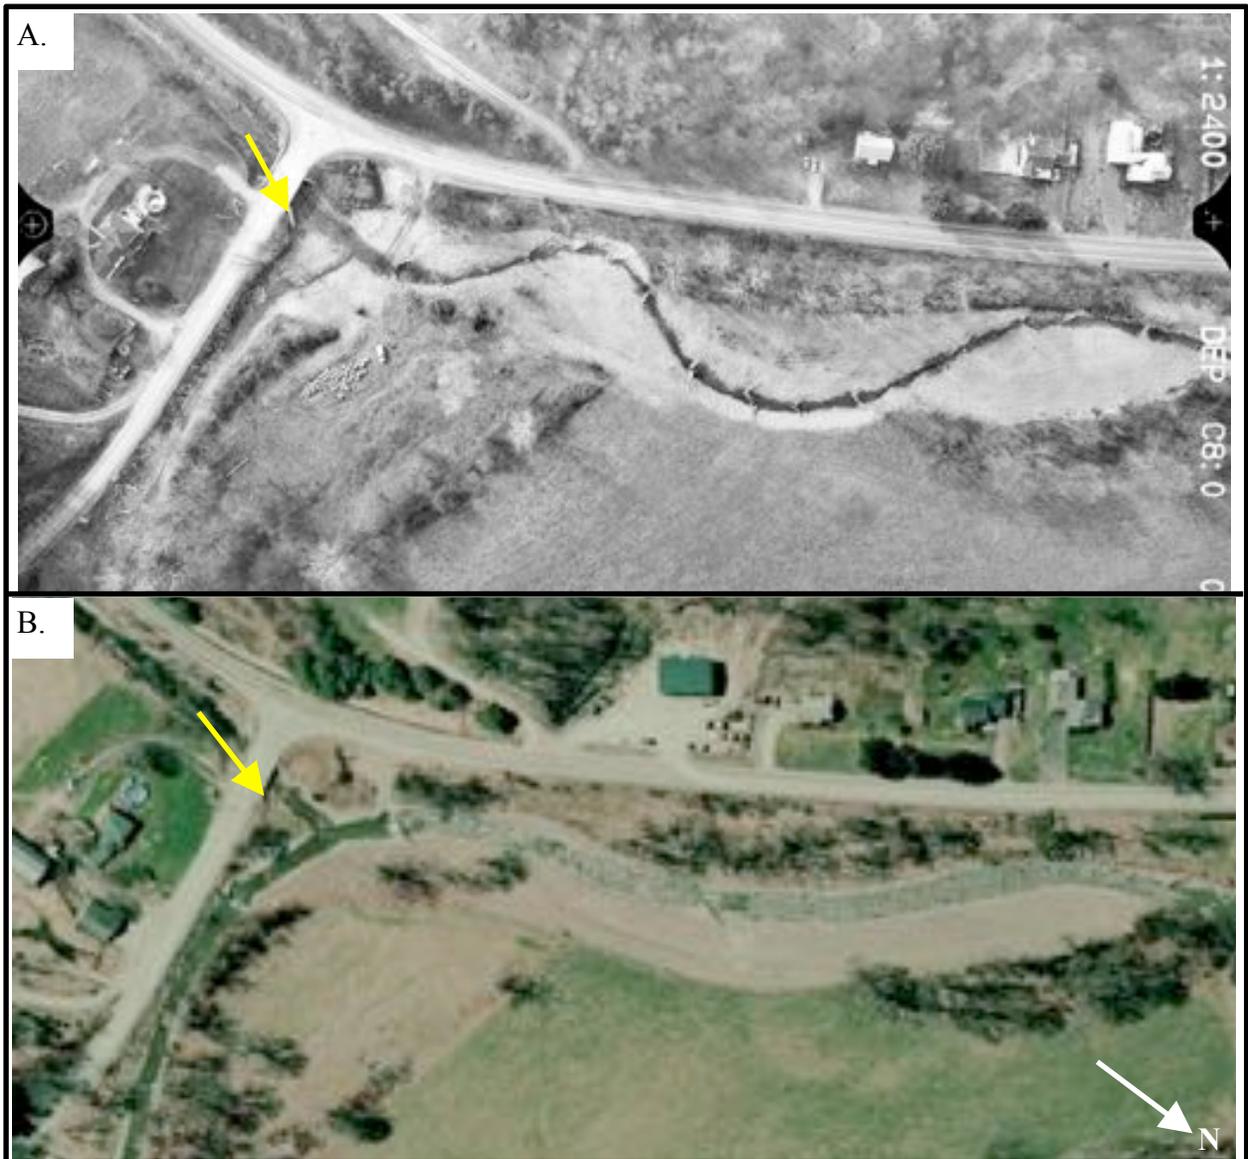
**Figure 9.** Comparison aerial photographs of Site 6 showing the difference in channel configuration from the first construction to today. Note the change from a sinuous reach to a almost straight reach after a high water event destroyed the structures. Yellow arrows identify the same point in both photographs. A) Aerial photograph taken shortly after construction was finished at Site 6 in 1999/2000. Photograph courtesy of USFWS, State College. B) Aerial photograph from Google Earth.

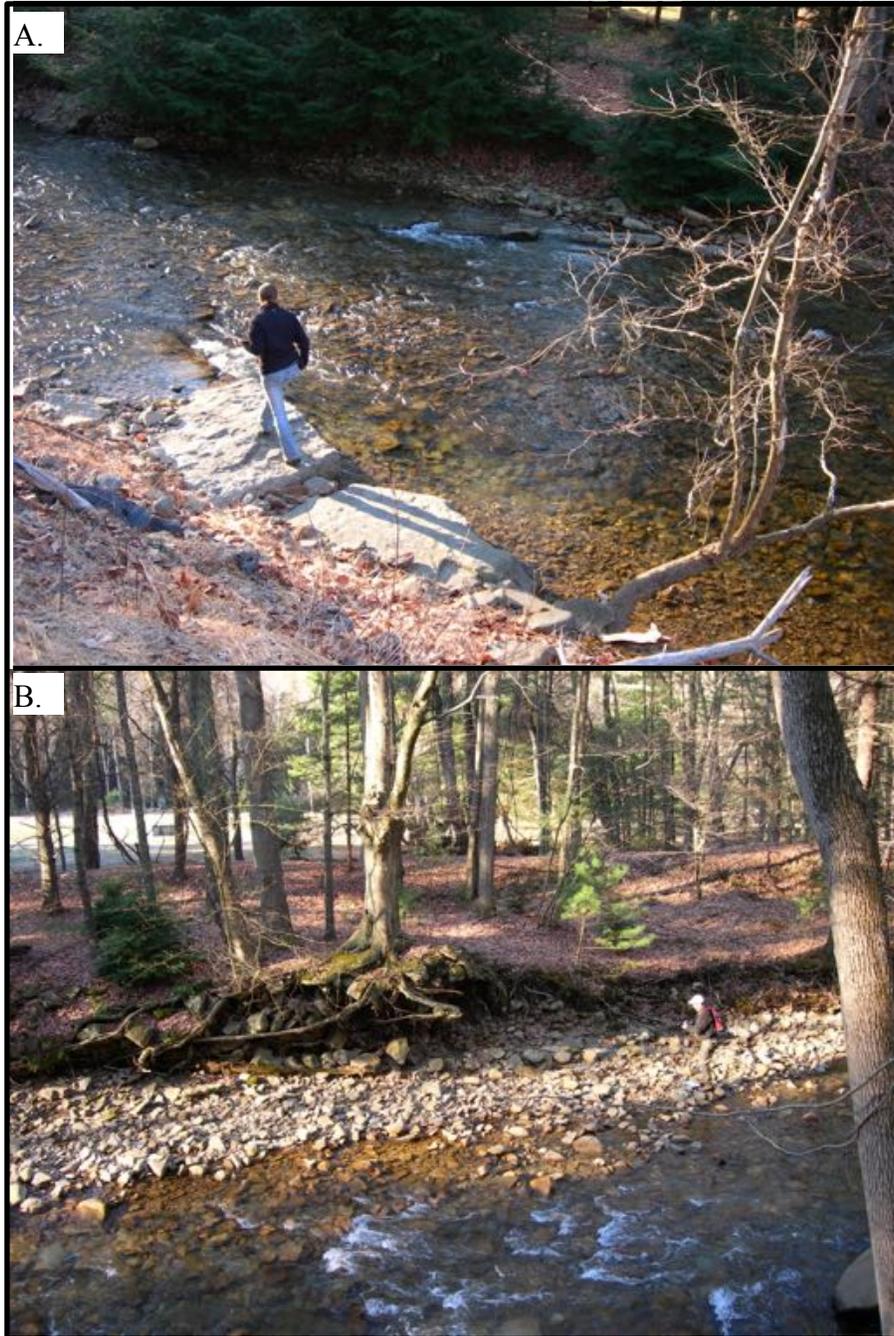
**Figure 10.** A) Photograph of a cross vane at Site 9. Note that the throat of this structure is buried by bedload to the point that a midchannel bar is beginning to form. There is no pool for fish habitat present at this structure, which is one of the goals of the structure design. B) Photograph of the left bank of the stream at Site 9. Note the exposed tree roots from the undercut bank and the deposition of the gravel bar at the same point in the stream. Photographs by R. C. Kochel.

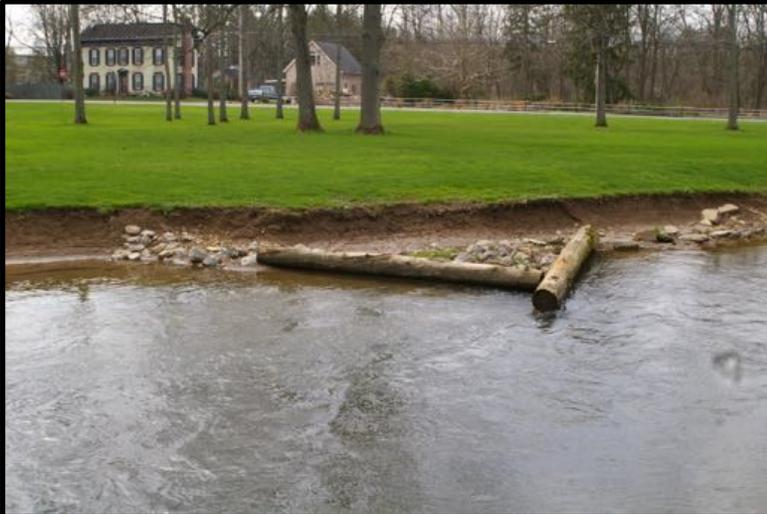
**Figure 11a.** Photograph of log/rock deflector at Site 10. Note that it is completely detached from the bank. A deflector's objective is to keep the thalweg in the middle of the stream and off the bank which this structure can do at normal flow. At higher flows though, the current will flow between the structure and bank potentially causing more bank erosion.

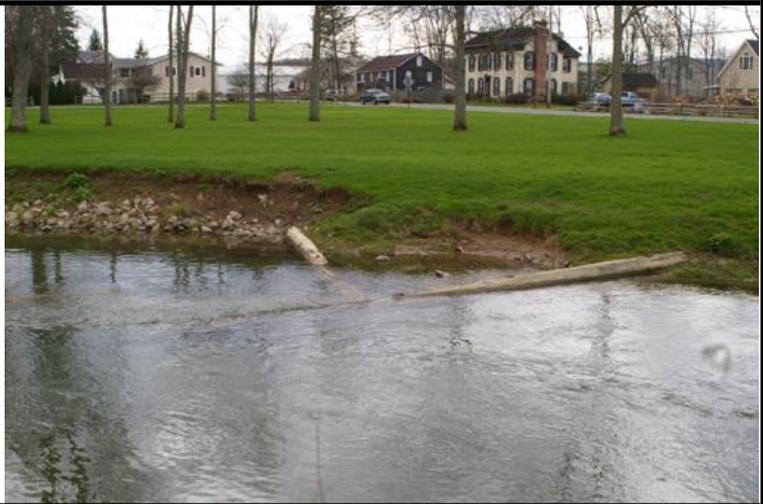
**Figure 11b.** Photograph of log/rock deflector at Site 10. Note that it is being undermined and collapsing into the stream. This structure cannot be as effective at controlling the thalweg since it is currently below the water surface.

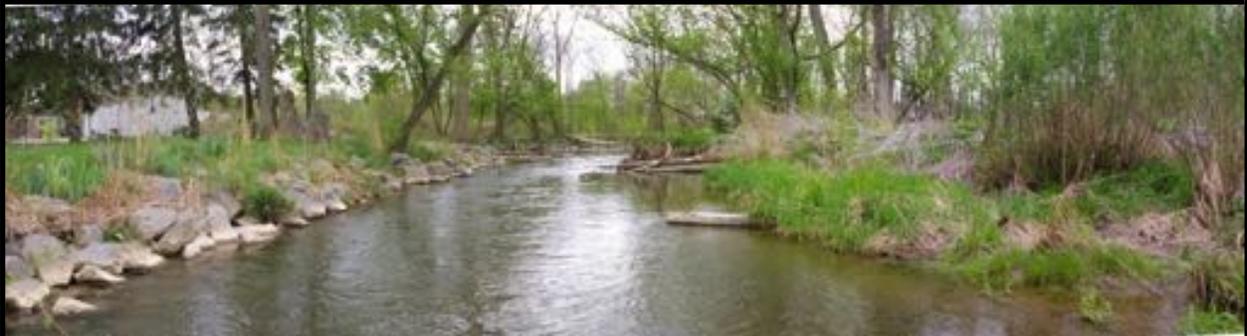
**Figure 11c.** Photograph of log vane at Site 10. Note that it is partially buried by a bar. This bar is made up of fine material. Also note that it has no control on the thalweg. All photographs by C. Kassab.

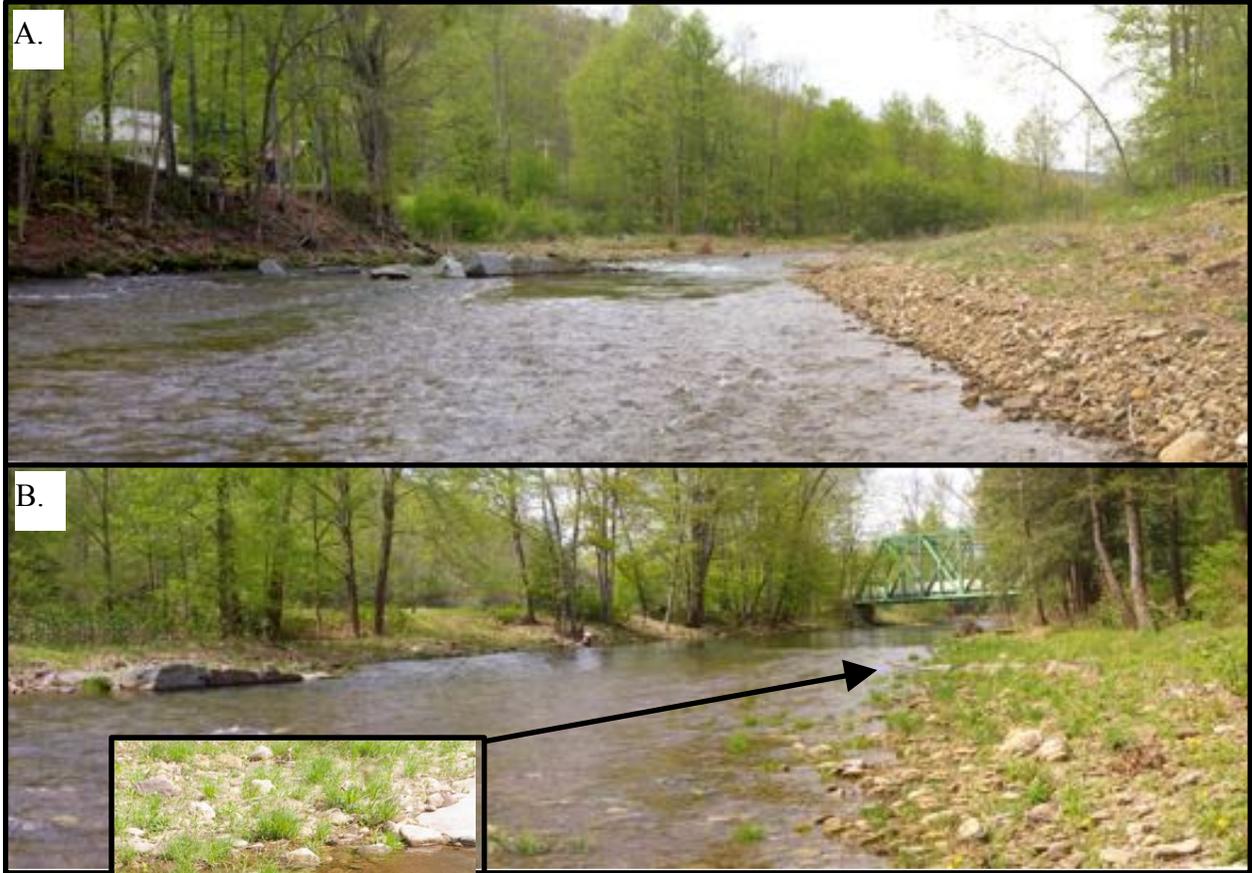
Overall, both of these sites are fairing well. An overview of site 23 is not included in this study because the assessment could not be completed due to the ongoing reconstruction efforts taking place. Also, some of the structures that were assessed were just installed this spring. At site 24 only one structure is ranked as having significant damage to the structure. All of the other structures have a ranking of two or less meaning that they are intact or slightly damaged. The erosion/deposition factor is the opposite. Of the six structures at site 24, all but one has significant deposition/erosion occurring that interferes with its functionality. Two structures are completely detached from the bank by at least 2 meters; they are sitting in the middle of the channel now (Figure 12a). All of the throats of the cross vanes are buried by bedload (Figure 12b).

**Figure 12.** Photographs from Site 24. A) Photograph of a rock vane which is fully intact but now sitting in the middle of the channel. At least 3 meters of bank erosion have occurred. The tip of the rock vane, which should normally sit in the middle of the channel now is beginning to be buried by the gravel bar on the left bank. B) Photograph of a cross vane in which the majority of the structure is buried by bedload. Note the inset photograph which is a close-up of the left wing being buried by bedload. The blueish rock is a structure boulder and the small rocks are bedload burying the left wing. Photographs by C. Kassab.

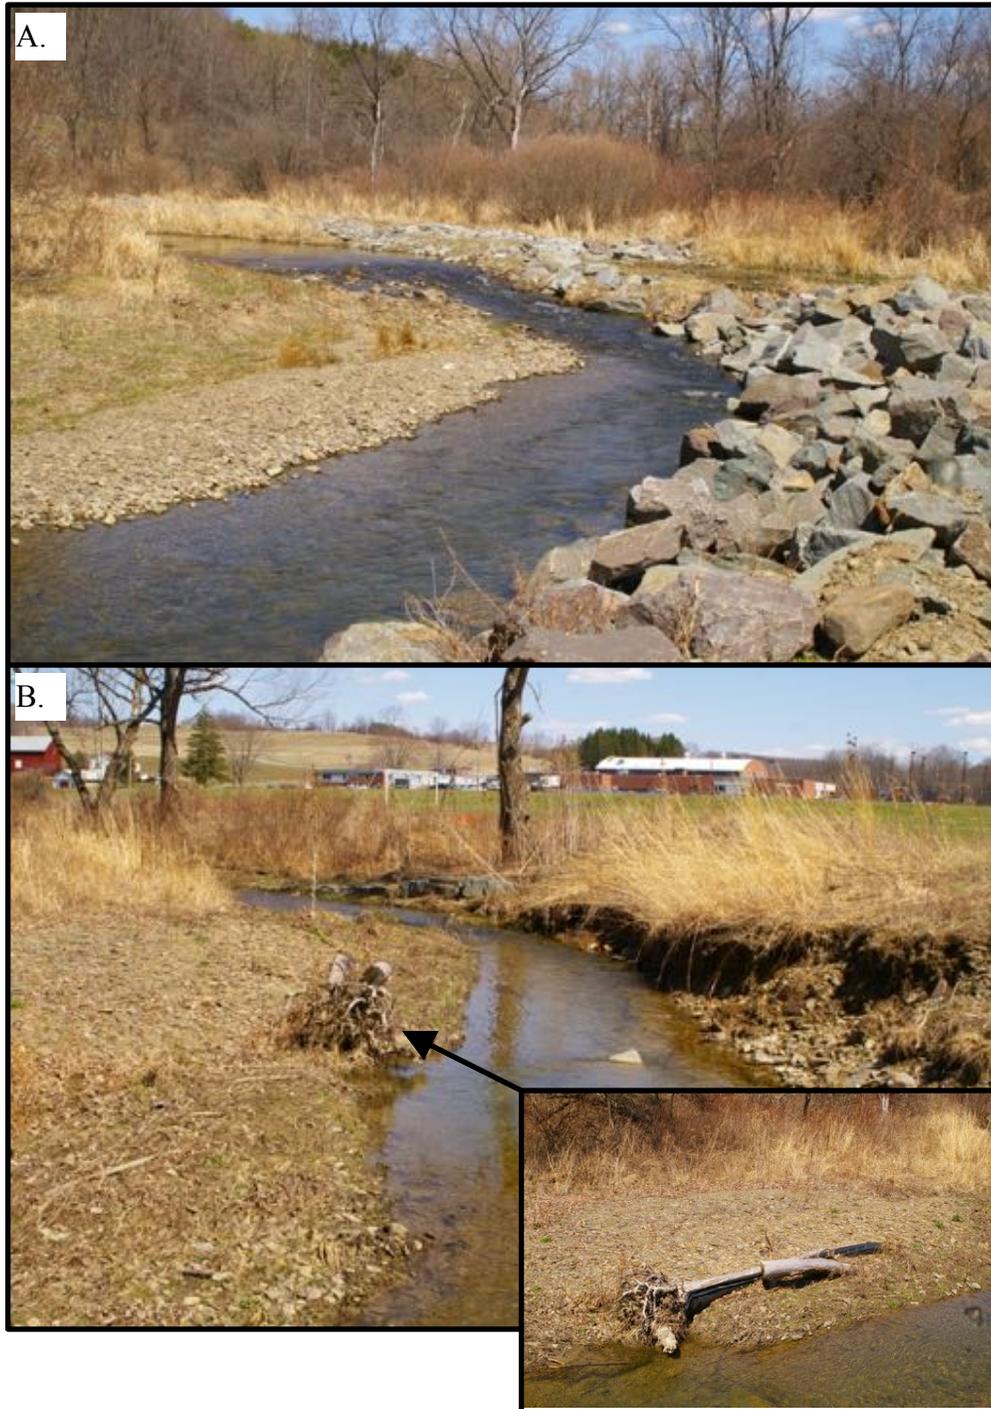
**Figure 13.** Photographs from Site 28. A) Photograph of the rip-rapped bank that replaced four structures at some point after the original construction. B) Photograph of the log vane that is supposed to be along the left bank and is instead resting on a gravel bar on the right bank of the stream. The inset photograph is a side view of the log vane. It could be identified as a structure to the geotech fabric that was wrapped around the log. Photographs by C. Kassab.

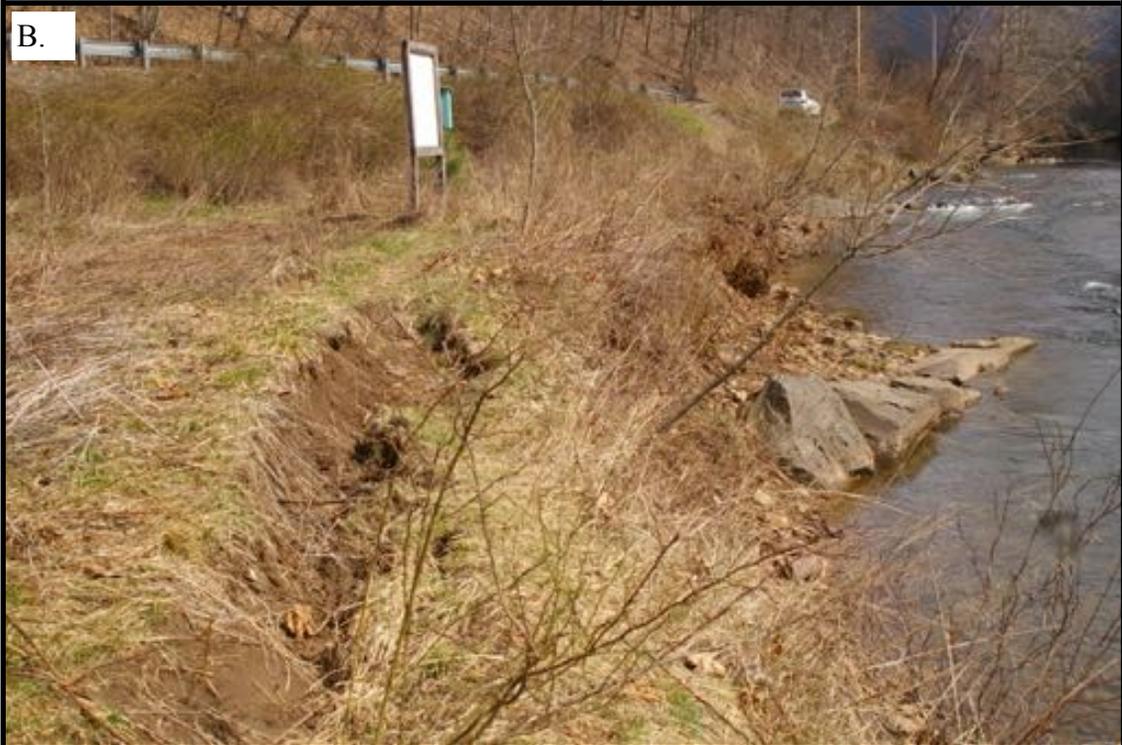
**Figure 14.** Photographs from Site 31. A) Photograph of the bank erosion prior to the construction of rock vanes and j-hooks. The date of the picture is unknown. B) Photograph of the current state of the bank at the same site. Bank erosion has been reduced, but there is still some including the bank slump in this picture. Photograph by C. Kassab.

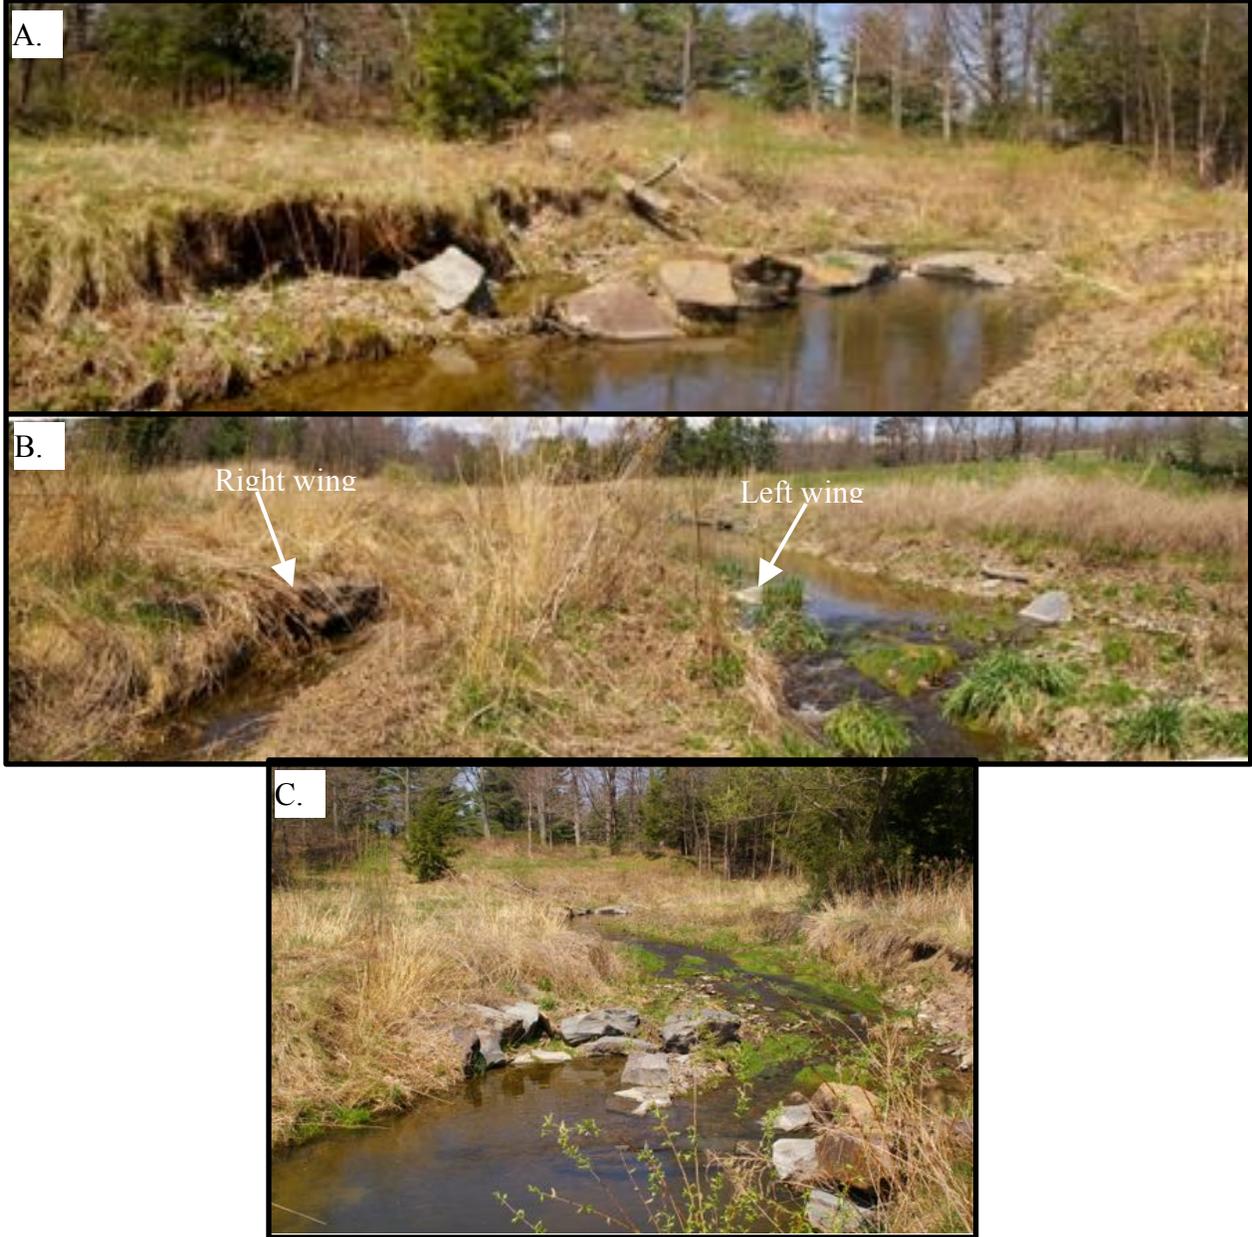
Less than 10% of the structures show significant damage, with only one structure being completely destroyed. Approximately 55% of the structures are fully intact with no damage which is good for a site that was constructed on fine-grained unconsolidated sediment and without anything to anchor the boulders into (Table 5). Partially because of the type of sediment this site was constructed in, erosion and deposition factors are high. Over half of the structures (~55%) have some significant erosion and/or deposition around the structure. A few of the structures are completely detached from the bank (Figure 15). None of these detachments are significant enough though to impact flow though (< 1 ft of detachment). Many of the structures are also experiencing deposition of gravel over part or even all of the structure. One structure is completely buried and the channel has shifted so that what used to be the left bank is now the right bank (Figure 15).

**Figure 15.** Photographs from Site 40. This site was constructed in mill pond sediments which as complexity to the overall integrity of the site. A) Photograph of a cross vane in which the right wing is completely detached from the bank, but a gravel bar has developed in the space between the bank and structure blocking the water from flowing there. B) Photograph of a cross vane that is no longer located in the active channel. The left wing is now along the right bank and a gravel bar has buried the structure. C) Note the vegetation in the channel. In many places along the stream this vegetation controls the flow during normal flow conditions impacting the functionality of the structures. Photographs by C. Kassab.

are still intact or only slightly damaged. Most of the structures, even though they aren't really damaged, are not controlling the thalweg as they should due to the burial of the structure and/or vegetation patches in the stream which influence the flow path (Figure 15).

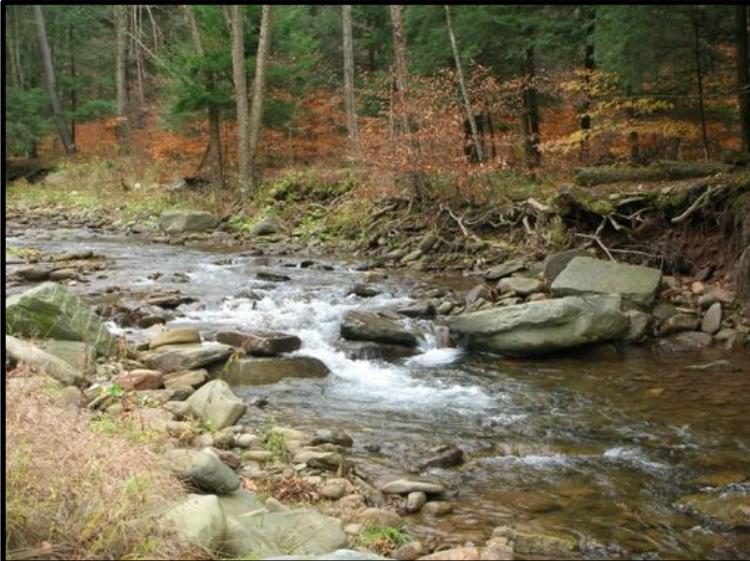
**Figure 16a.** Photograph of a failed step pool at Site 43. This was the only site to use step pools and all of them failed less than two months after they were installed. Photograph by C. Kassab.

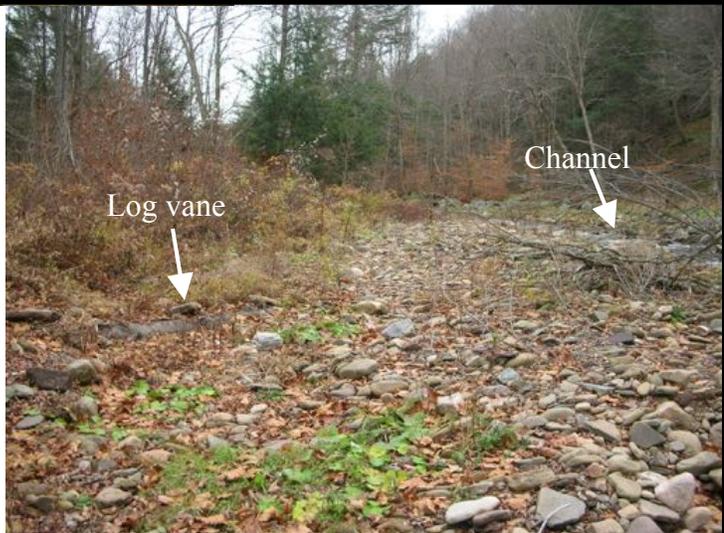
bar and the channel has shifted away from it at least 10 feet (Figure 16). Many of the other structures are still located in the channel but the throat rocks are being buried by bedload or gravel bars are beginning to bury the wings.

**Figure 16b.** Photograph of a log vane that is no longer in the active channel at Site 43. In fact the channel has shifted at least 10 feet from the constructed channel. Photograph by C. Kassab.

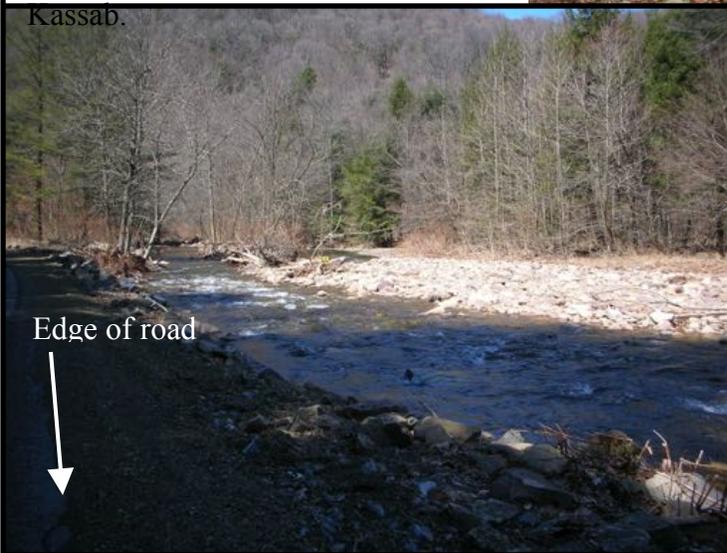
**Figure 16c.** Photograph showing the amount of aggradation that is common in the reach of stream between Sites 42 and 43. The gravel bar along the right bank has aggraded to the floodplain level and is forcing the stream to flow along the road. During high water events, the road is probably flooded. Photograph by C. Kassab.
