Monitoring and Modeling of the Hydraulic and Sediment Processes at In-Stream Restoration Structures in the Vicinity of a Bridge Crossing

A Thesis

Presented to the Faculty of
Bucknell University
In Partial Fulfillment of the Requirements for the Degree of
Master of Science in Civil Engineering

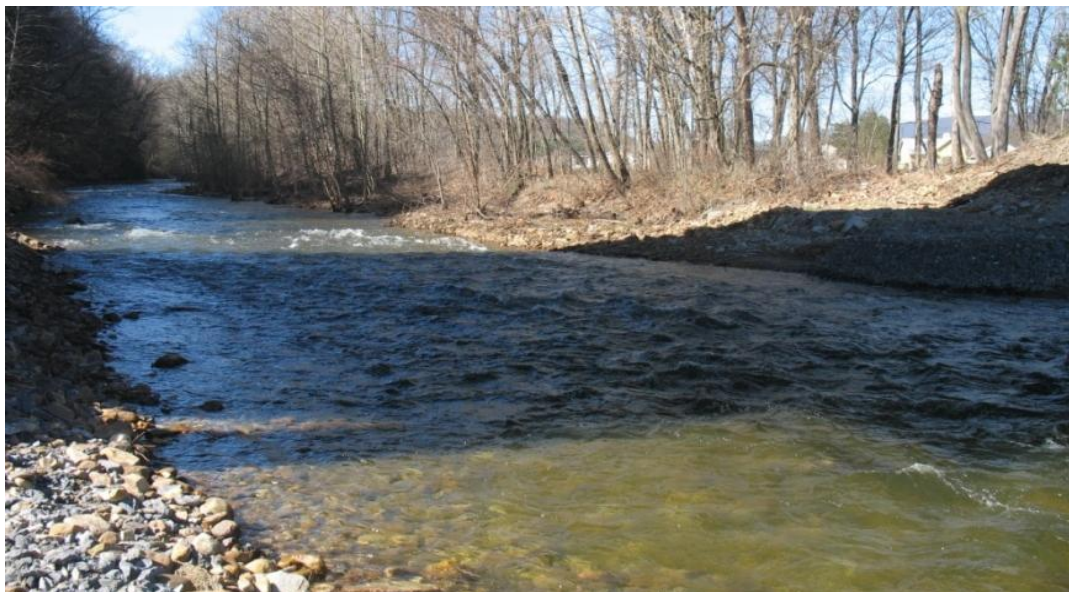
Figure 2 – White Deer Creek upstream of the Old Route 15 Bridge, facing upstream (Image taken on 3-17-2010).

An ideal site was selected that experienced many of the problems discussed in the previous sections. The presence of a bridge crossing, historic deforestation/alteration of the watershed, and the installation of engineered cross vanes to mitigate aggradation at the bridge crossing are all found in White Deer Creek near White Deer, PA. The presented research focuses on the lower section of White Deer Creek at the Old Route 15 Bridge crossing. White Deer Creek is a tributary to the West Branch of the Susquehanna River beginning near Lavonia, PA and ending at White Deer, PA. Due to the surrounding ridges causing its long narrow shape, the White Deer Creek watershed is a trellis type watershed. The approximate watershed area is 122 square kilometers, with the majority of it currently being forested (94.5%). Figures 2 and 3 are current images of the research area on White Deer Creek.

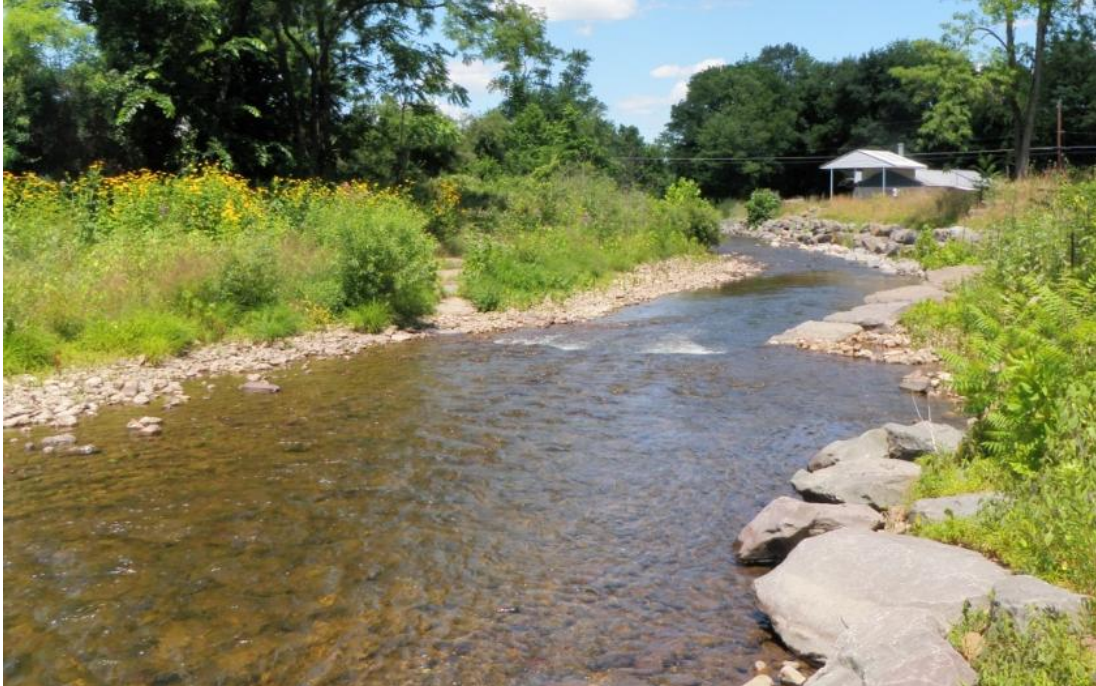
Figure 3 – White Deer Creek downstream of the Old Route 15 Bridge, facing downstream (Image taken on 9-23-09).

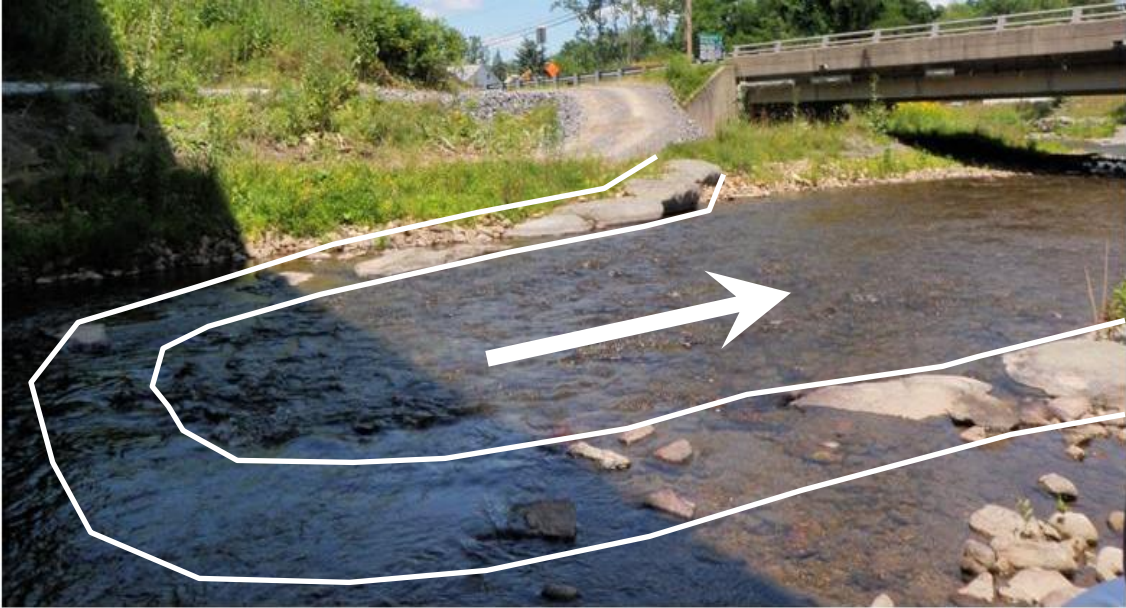
Figure 5 – Image of the upstream rock cross vane (white lines) and the large gravel/cobble sized sediment that has buried it (White arrow shows flow direction).

Since the completion of the restoration project, the upstream cross vane has completely filled in with sediment (Figure 5) and does not have a scour hole as intended by design (see Figure 1), while the downstream vane is still functioning (Figure 4b), despite several spots where the boulders in the cross vane wings have started to pull apart and move from their original locations. The channel cross sections throughout the entire restored reach have become less uniform than when the project was constructed, and several sections of the riprapped bank (downstream of the bridge) have loosened and even fallen into the channel (Figure 6).

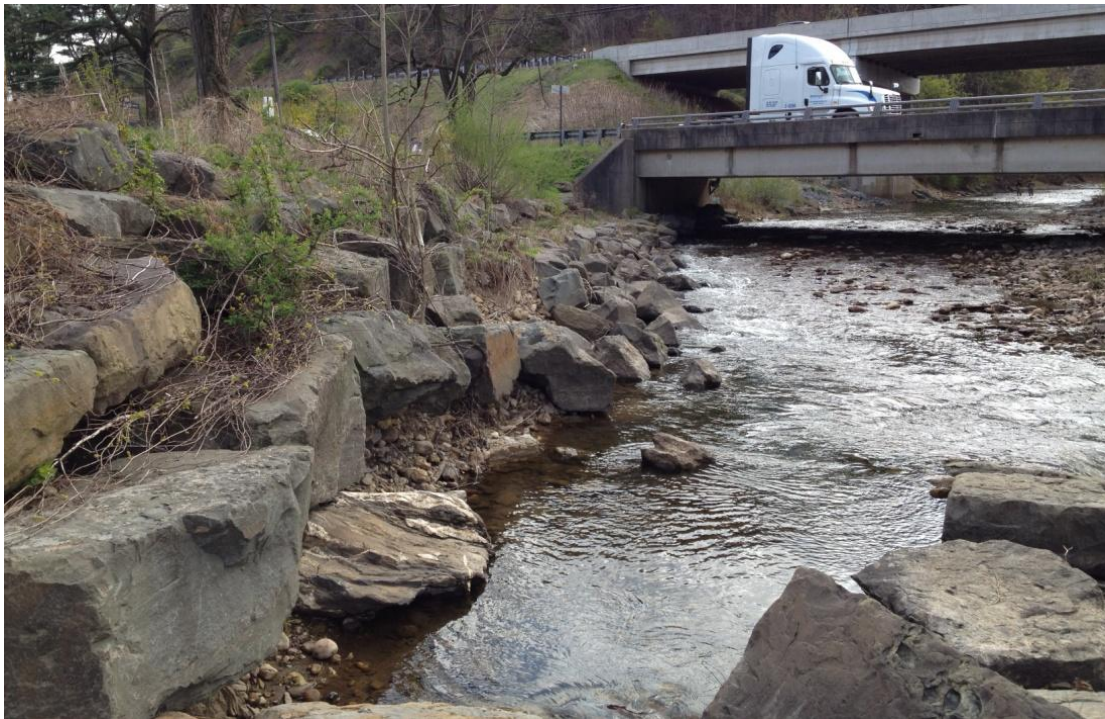
Figure 6 – Image of a failed section of the riprapped bank downstream of the Old Route 15 Bridge (facing upstream).

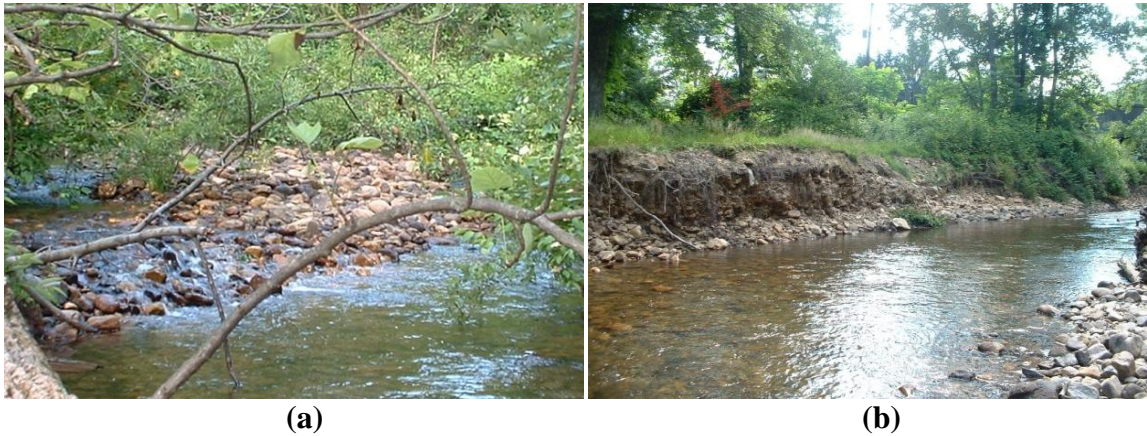
Figure 9 – Images taken during the second day investigation of White Deer Creek. (a) Aggradation between two older vegetated bars. (b) Eroded section of a bank (approx. 1.25 meters high).

current US Route 15 Bridge near the study site. As shown in Figures 9a and 9b, sediment aggradation and erosion were visible at several locations throughout the reach. The sediment sizes in the creek were similar to what is found at the research site. In certain areas of this section, the creek flows directly over shale bedrock and no sediment is on the bed as shown in Figure 10.

The results of the watershed investigation provide information regarding sediment sources, storage and processes occurring naturally in the channel. Figures 9, 11, and 12 show that transported sediment has come from sources such as bank erosion and active depositional bars throughout the channel and its floodplain. It was observed that sediment is stored within large bars in the channel and in smaller side channels that are only active during storm events. All pebble count data taken during the watershed investigation is summarized in a sediment size distribution plot, Figure 14. The sediment sizes follow the general trend that as you move farther upstream in the watershed, the sediment found in the streambed generally increases in diameter.

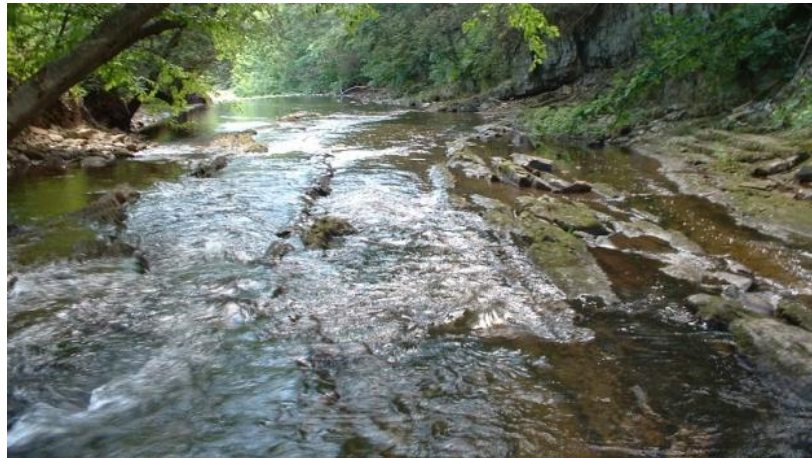
Figure 10 – Image taken during the second day investigation of White Deer Creek showing the shale bedrock channel bed.

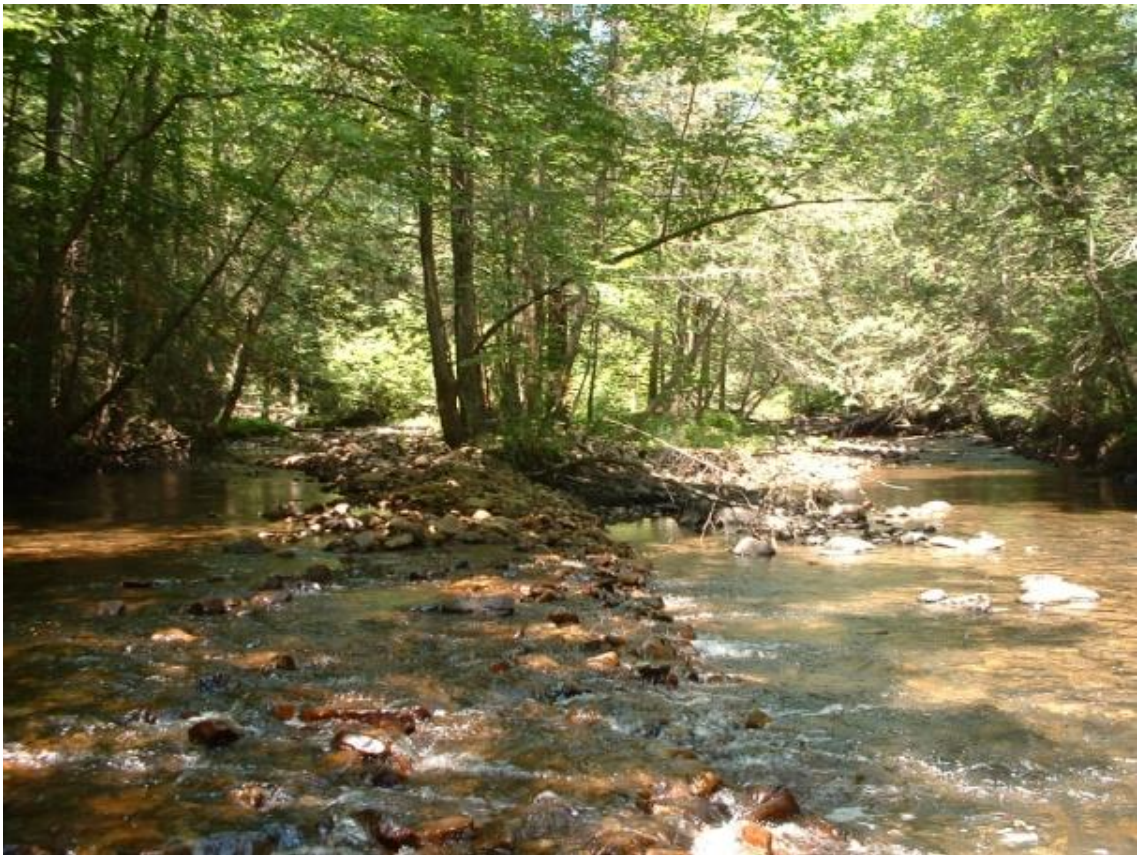
Figure 11 – Image taken during the third day investigation of White Deer Creek displaying a large aggradation bar angled across the span of the channel.

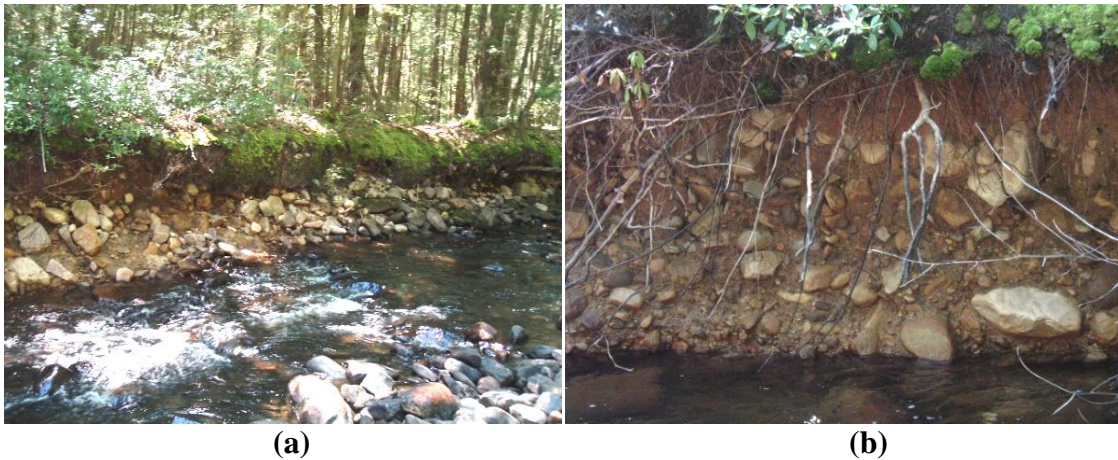
Figure 12 – Images taken during the fourth day investigation of White Deer Creek. (a) Section of significant bank erosion. (b) Showing the sediment stored within the bank.

The fourth day investigation was conducted 8.9 kilometers upstream from the research site. The investigation passed over an existing dam used for a water supply reservoir and owned by PA American Water. This reach is experiencing many areas of erosion as shown in Figures 12a and 12b.

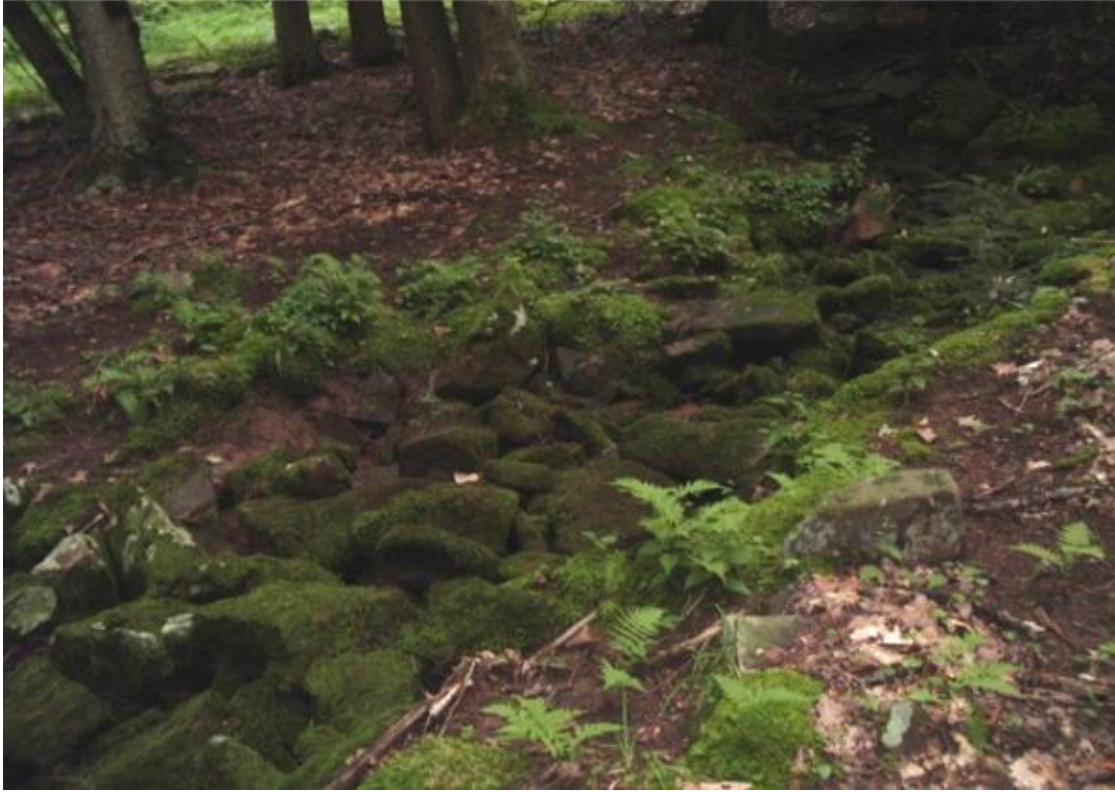
The fifth investigation was the farthest upstream within the watershed. It was conducted 25 kilometers upstream from the research site on a tributary to the main stem of White Deer Creek. Figure 13 below shows a typical section of the creek at this location. In this area, the creek would disappear beneath the surface and reappear in very rocky sections farther downstream.

Figure 13 – Image taken during the fifth day investigation of White Deer Creek.

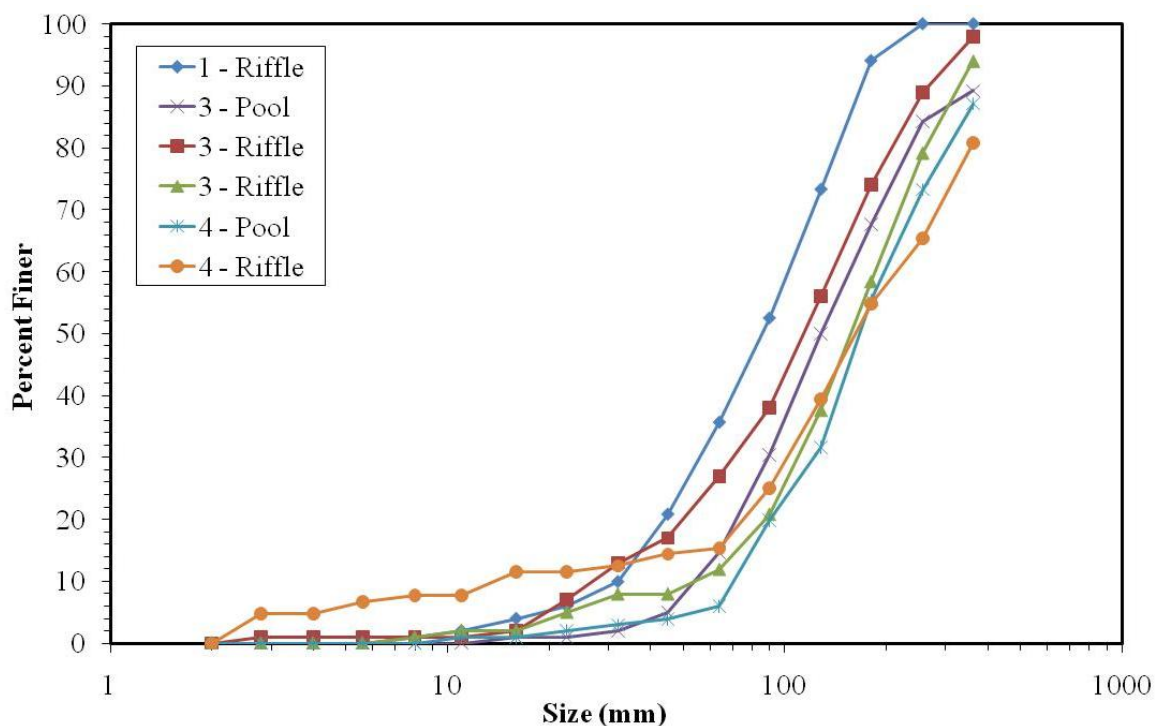
Figure 14 – Sediment size distribution plot for the pebble counts taken during the White Deer watershed investigation (Pebble counts are labeled according to reach number and location taken).

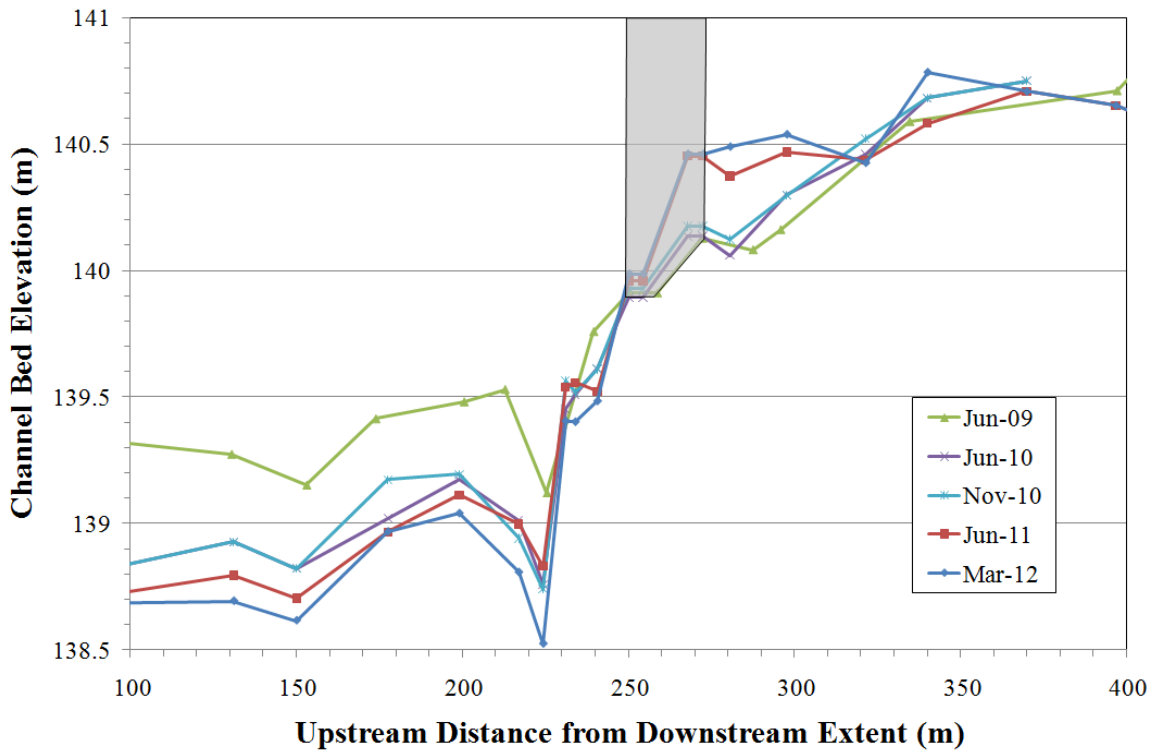
Figure 15 – Channel bed profile plot of each survey taken on White Deer Creek.

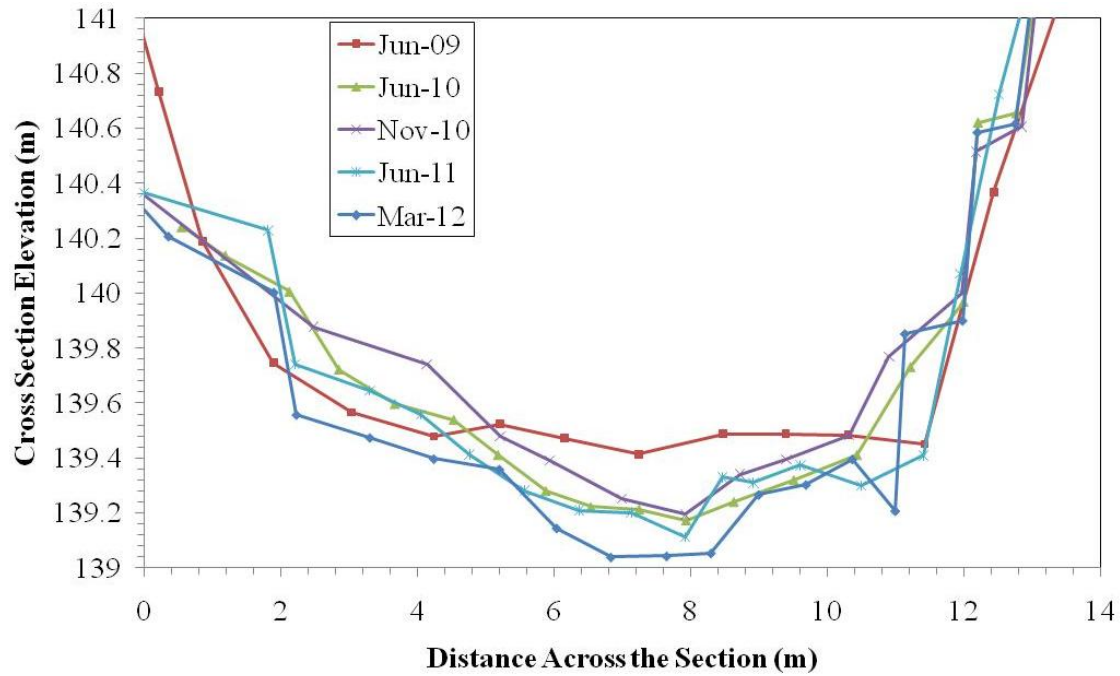
Figure 16 – Cross section data collected downstream of the Old Route 15 Bridge crossing.

The channel cross sections were compared to detect more detailed changes between surveys. Figure 16 shows cross section data of White Deer Creek collected 55 meters downstream of the Old Route 15 Bridge crossing. Figure 17 shows cross section data collected 12 meters upstream of the Old Route 15 Bridge crossing.

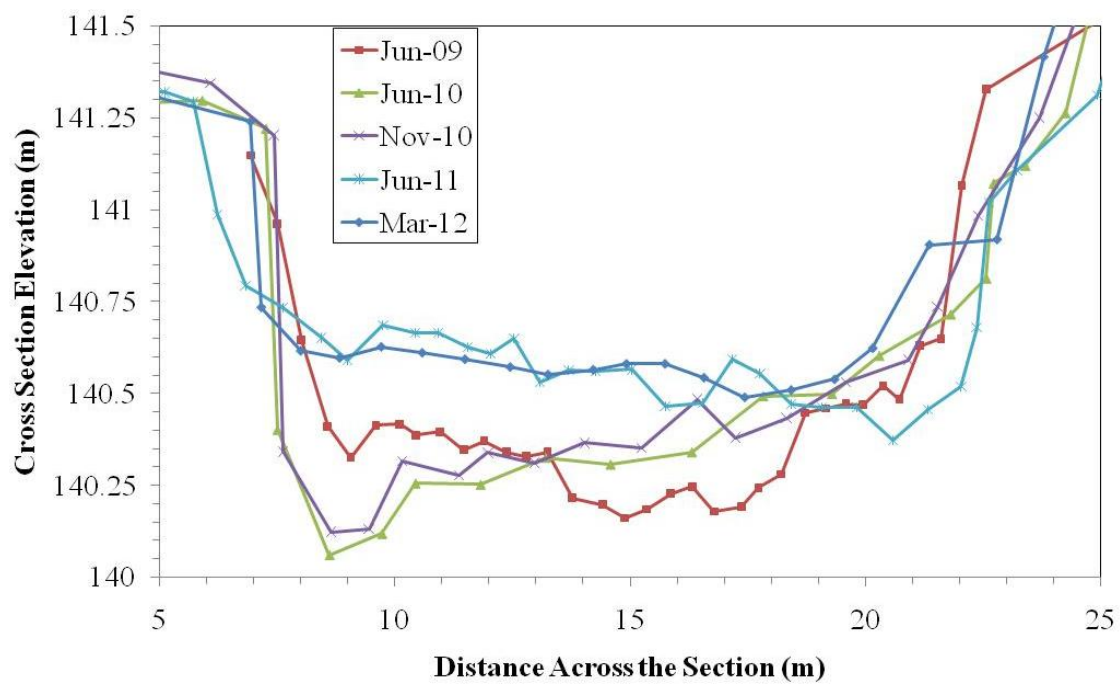
Figure 17 – Cross section data collected upstream of the Old Route 15 Bridge crossing.

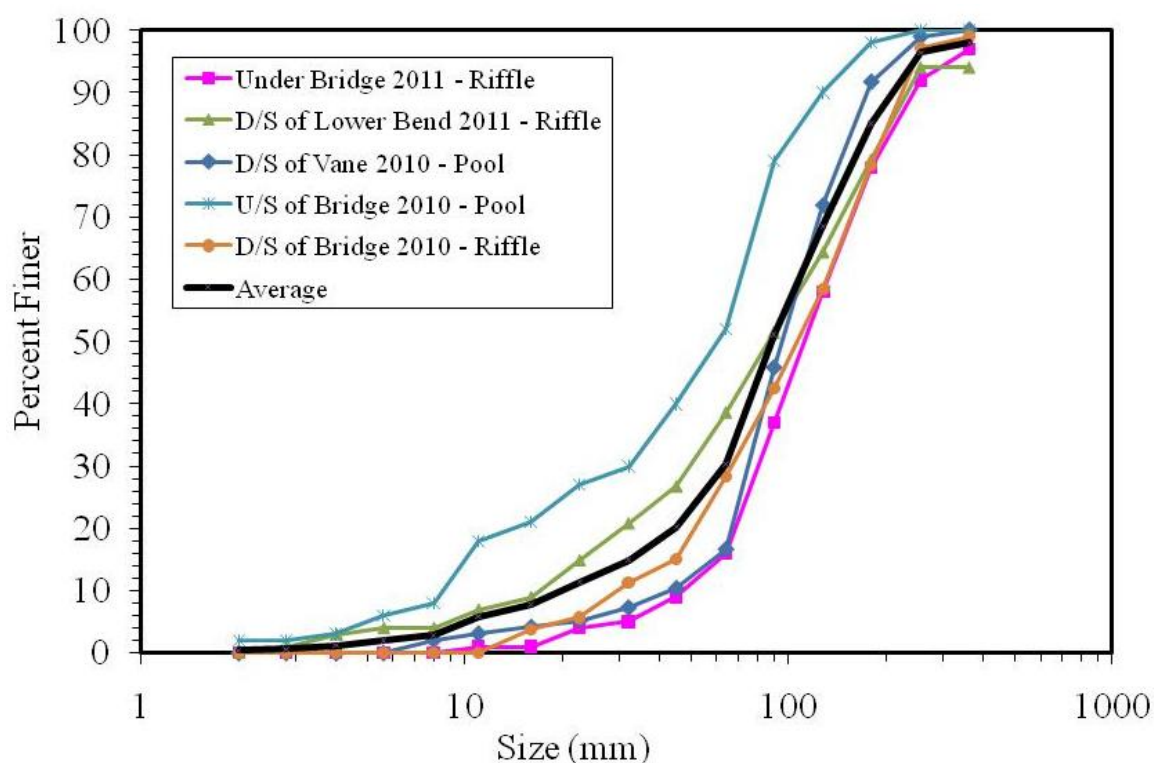
Figure 18 – Measured sediment size distributions at various locations on the White Deer Creek research site (Legend refers to the Old Route 15 Bridge).

A total of five pebble counts were taken throughout the study site during the research period, three of which were taken during 2010 and the remaining during 2011. The three taken during 2010 were spaced accordingly: (1) in a pool upstream of the Old Route 15 Bridge, (2) in a riffle between the bridge and the downstream structure, and the last (3) in a pool downstream of the downstream structure. The first of the 2011 pebble counts was taken in a riffle section directly beneath the Old Route 15 Bridge and the second was taken at the lower end of the research site located in a riffle section just downstream of a bend in the channel. All of the pebble count data is shown in Figure 18 along with an average of all pebble counts.

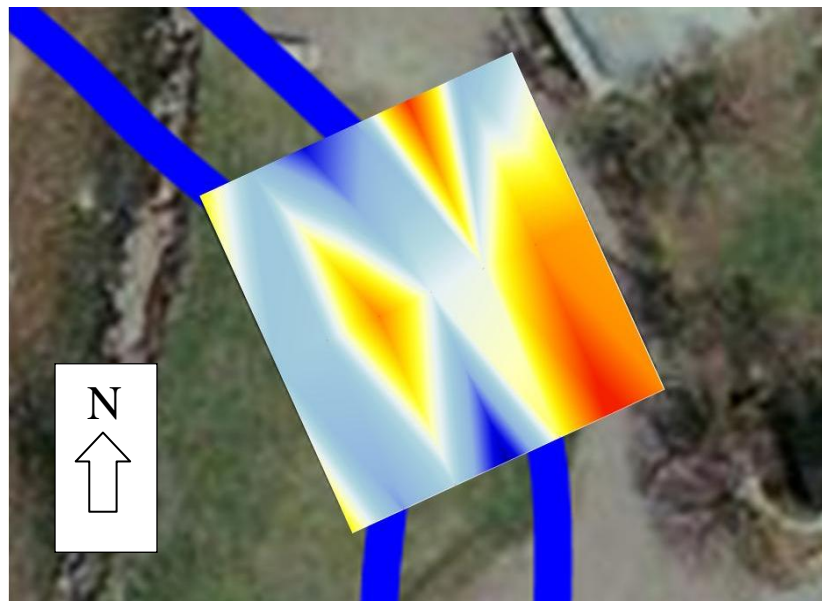
Figure 21 – Contour map of the gravity measurements taken at the White Deer Creek study site, refer to Figure 20 for location on site.

The gravity measurements were setup in a 25 m x 25 m grid outlined in the yellow zone in Figure 20. The blue line represents the approximate channel location that was investigated. Figure 21 shows the gravity analysis results overlain on an image of the study area.

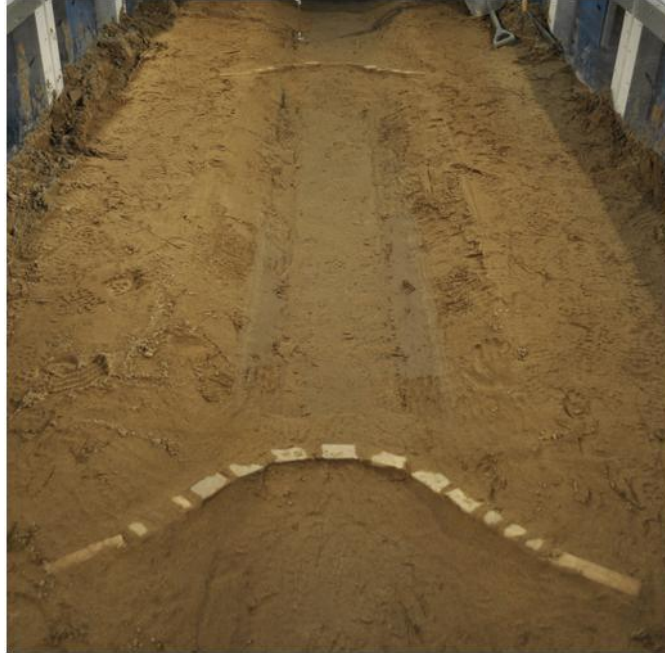
Figure 22 – Photograph of the initial setup for trial 1 (facing upstream).

The initial setup for trial one is shown in Figure 22. The straight channel had two cross vanes in place and was run with no sediment loading at the upstream end of the channel. Figure 23 displays an image taken while measuring velocity as the trial was taking place, and Figure 24 displays the measured velocities in a contour plot. The contour plot shows velocity directions, indicated by the arrows, and magnitudes, indicated by arrow size and contour color. The black bold lines represent the locations of the cross vanes. The flow is roughly 76 mm deep and has eroded away the sloped banks to create a more rectangular channel. The velocity increases in the center of the channel downstream of the cross vanes and from looking at Figure 23, the flow does converge over the vane as intended by the design of the structure.

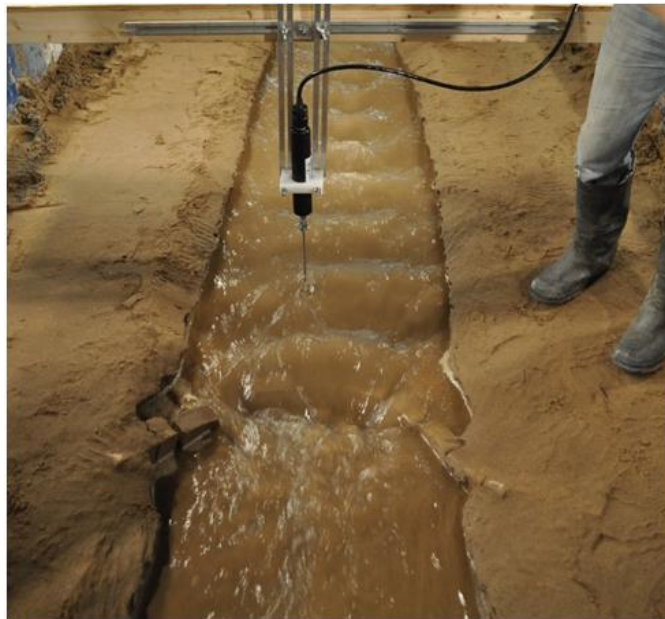
Figure 23 – Velocity measurements taking place during trial 1 (facing upstream).

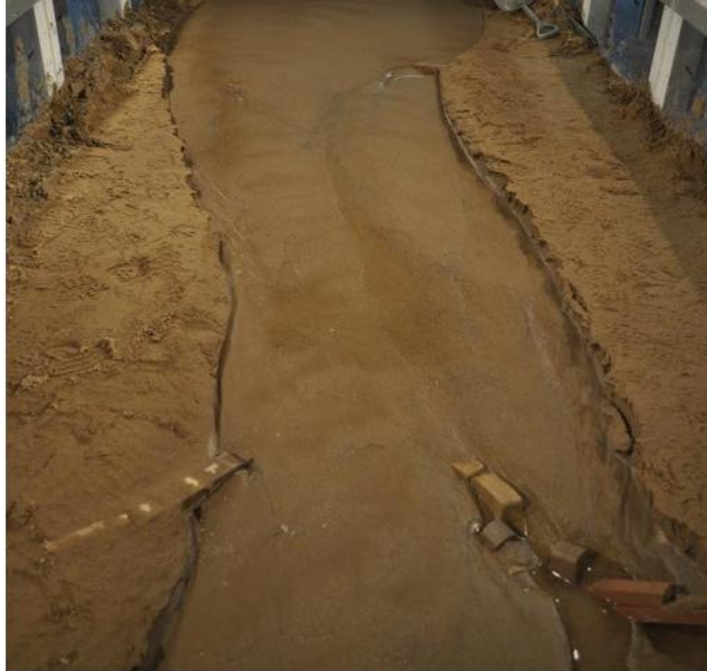
Figure 25 – Photograph of the resulting channel from trial 2 (facing upstream).

The setup for trial two was the same as trial one with two cross vanes on a straight channel. However, trial two was run with a high sediment loading rate at the upstream end of the channel. This was accomplished by using the sediment recirculation pump. The end result of the trial is shown in Figure 25. From looking at the resulting channel photograph, the channel had changed from a straight channel to a meandering channel. Both cross vanes were buried by sediment, and the channel had widened by up to 150 percent at several sections.

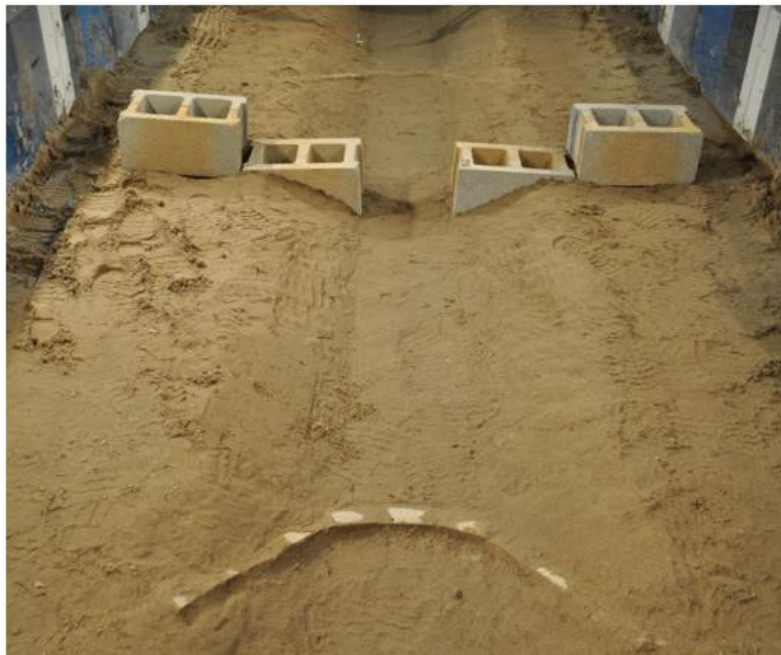
Figure 28 – Photograph of the initial setup for trial 4 (facing upstream).

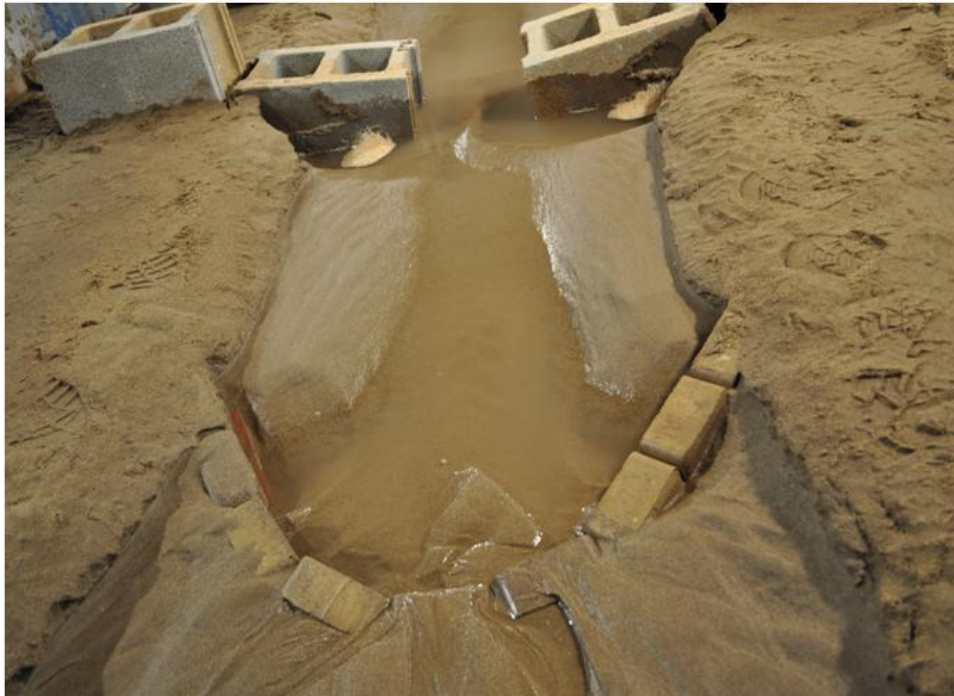
Figure 30 – Photograph of the upstream cross vane after trial 4 (facing downstream).

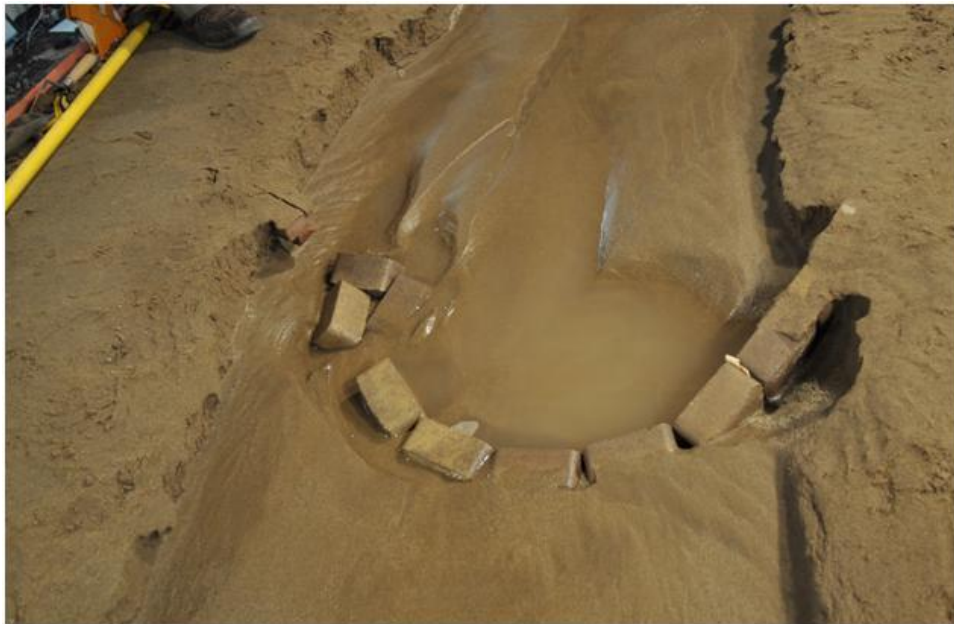
Figure 31 – Photograph of the downstream cross vane after trial 4 (facing downstream).

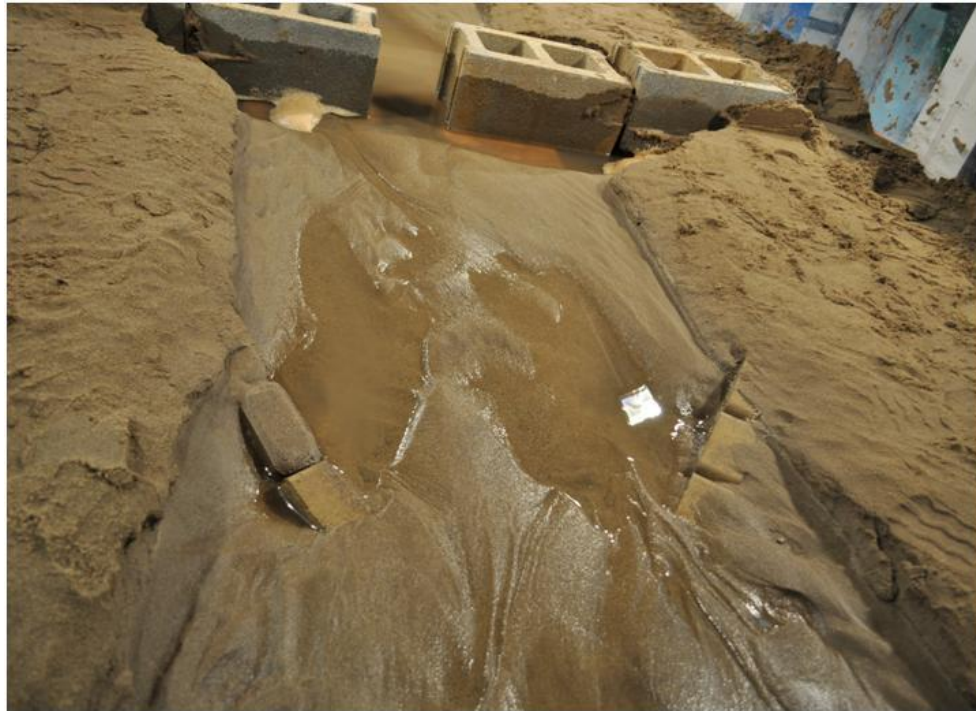
Figure 32 – Photograph of the upstream cross vane after trial 5 (facing downstream).

The initial setup of trial five was similar to trial four but the bridge now only had a 0.2 meter opening and also was supported beneath the cinderblocks by a slab of wood to prevent undercutting of the structure as occurred in trial four. The set up of trial five provided a more realistic representation of the bridge foundation. A moderate sized sediment pile also was located at the very top of the flume to provide a pulse supply of movable sediment for the channel to transport. Looking at the channel photos, Figures 32 and 33, the bridge again failed on its right side and forced the water to the left side of the downstream cross vane. This caused the left side of the cross vane to fail. One major difference between trials four and five was that the upstream vane was covered with sediment following the trial run.

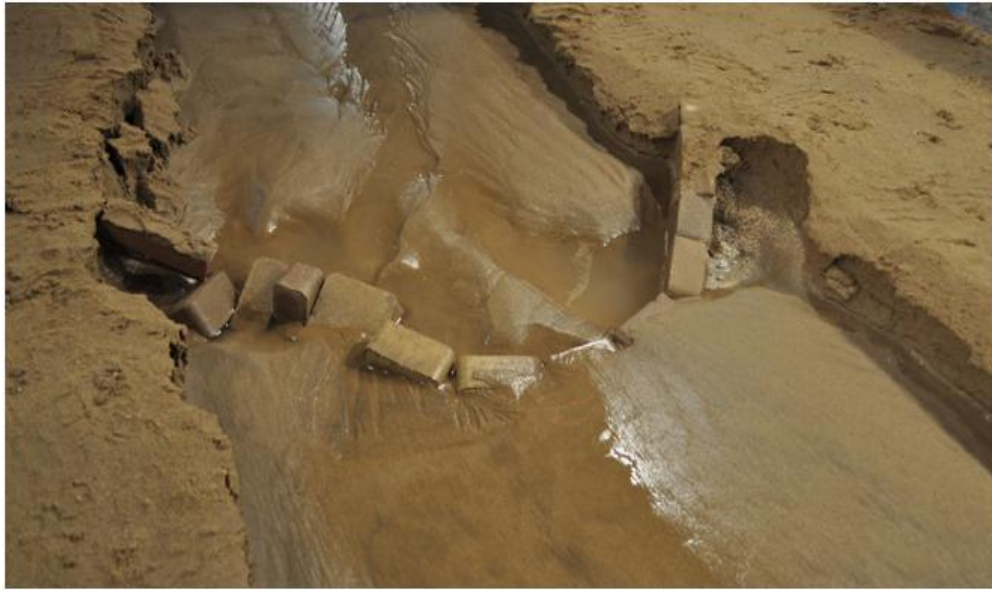
Figure 33 – Photograph of the downstream cross vane after trial 5 (facing downstream).

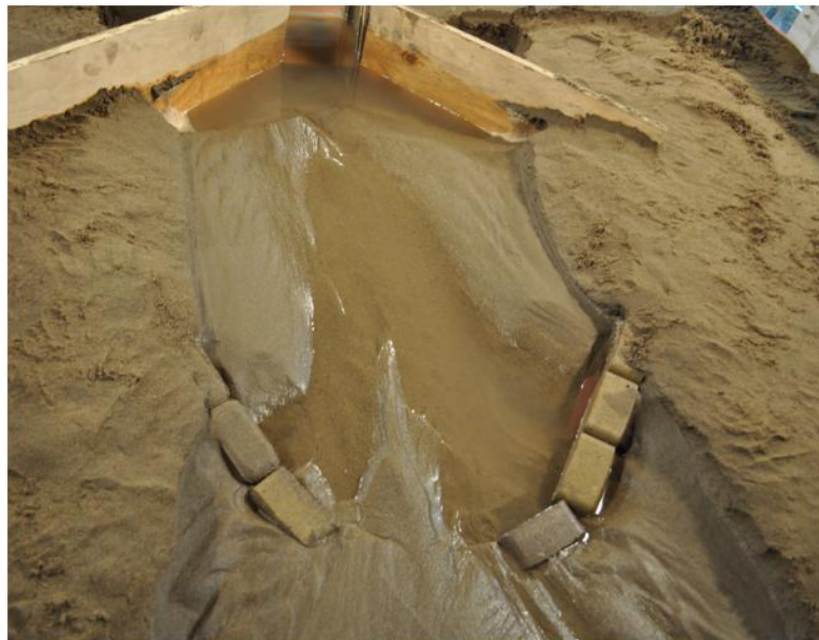
Figure 35 – Photograph of the upstream cross vane after trial 6.

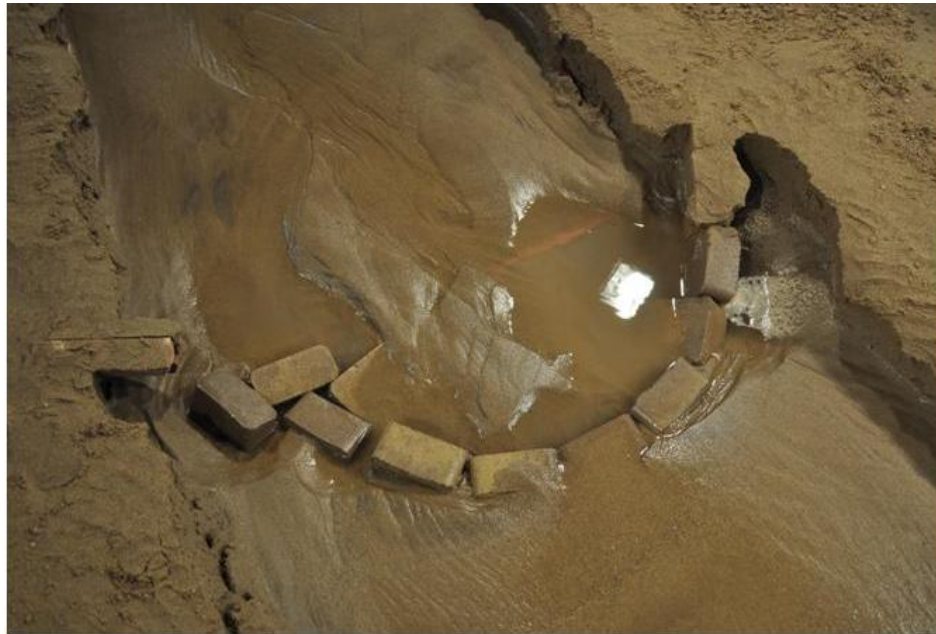
Figure 36 – Photograph of the downstream cross vane after trial 6.

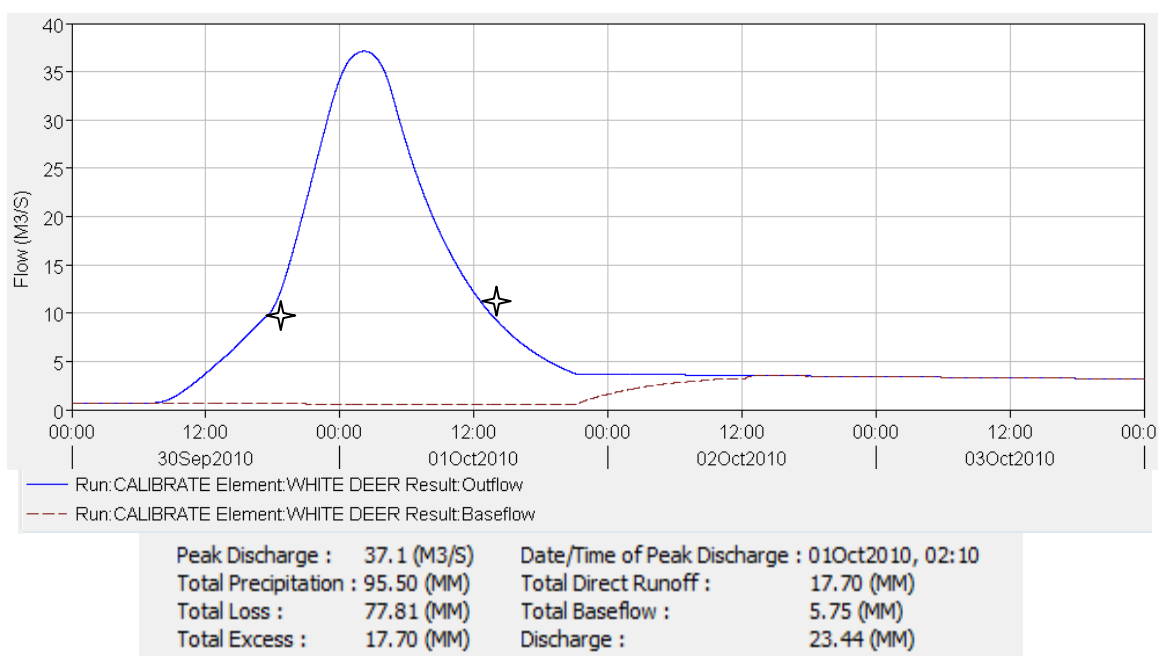
Figure 37 – Resulting hydrograph from HEC-HMS for the October 1st, 2010 storm data (stars indicate flows measured with the ADCP).

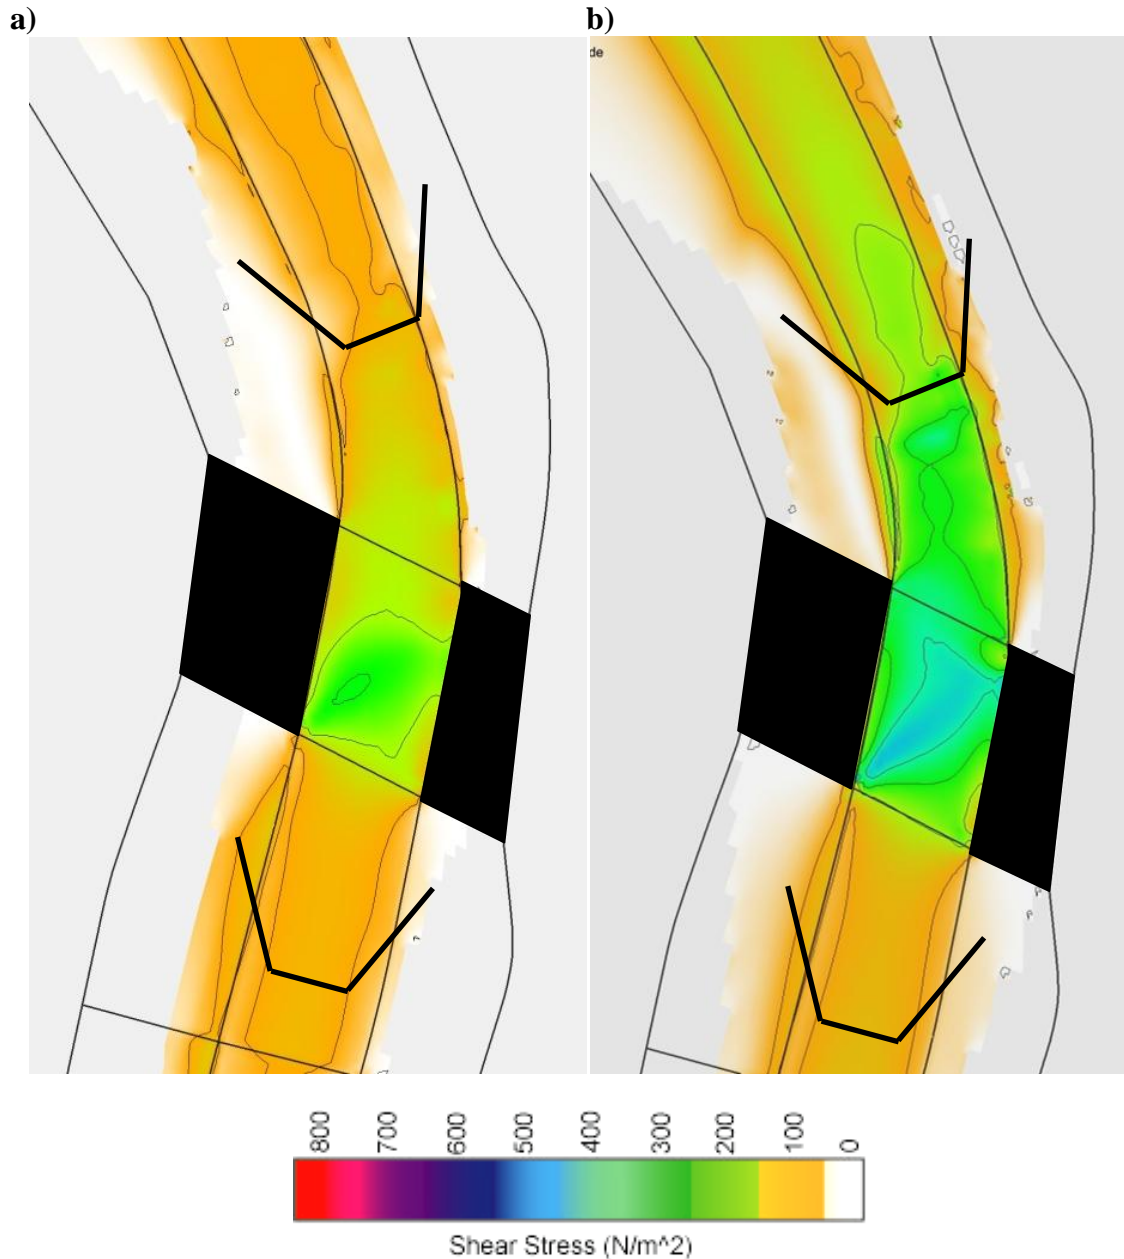
Figure 42 – FESWMS shear stress contours for the March 2012 survey at the two and ten year flow rates (a and b, respectively) (The black rectangles indicate the bridge (a 14 m x 21 m span) and approximate location of the restoration structures).

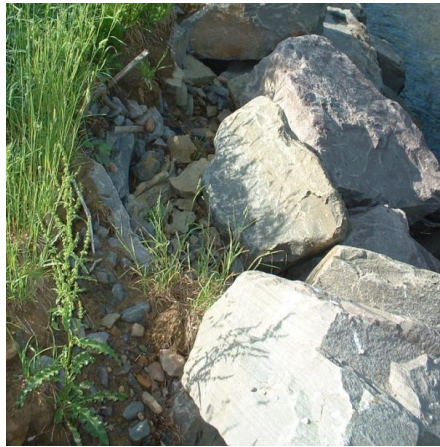
Figure 43 – Image of the bank erosion downstream of the downstream restoration structure (facing upstream).

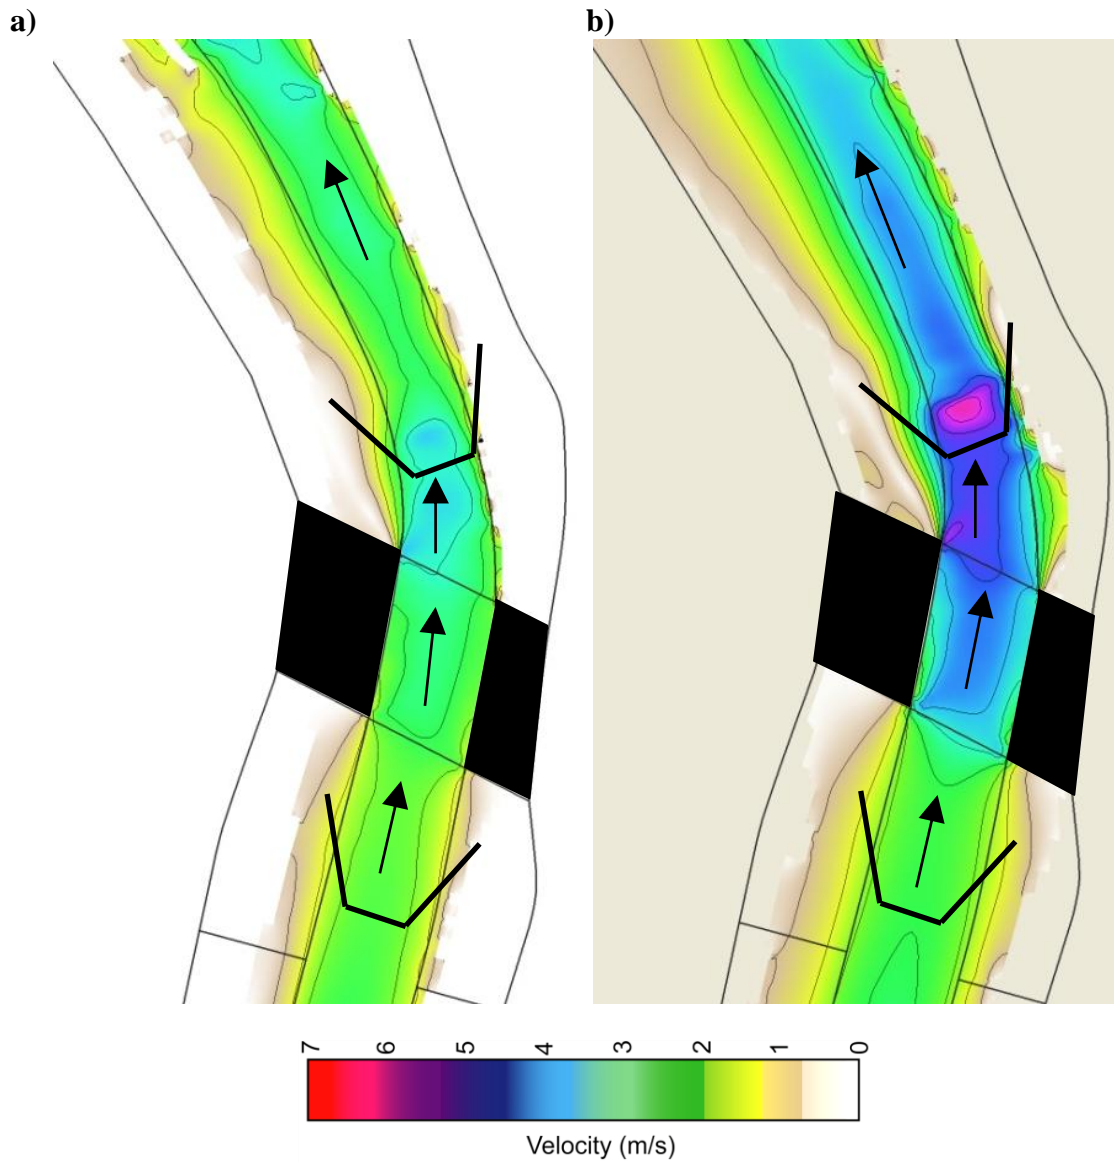
Figure 46 – FESWMS velocity contours for the November 2010 survey at the two and ten year flow rates (a and b, respectively) (The black rectangles indicate the bridge (a 14 m x 21 m span) and approximate location of the restoration structures).
