Monitoring and Modeling of the Hydraulic and Sediment Processes at In-Stream Restoration Structures in the Vicinity of a Bridge Crossing

A Thesis

Presented to the Faculty of
Bucknell University
In Partial Fulfillment of the Requirements for the Degree of
Master of Science in Civil Engineering

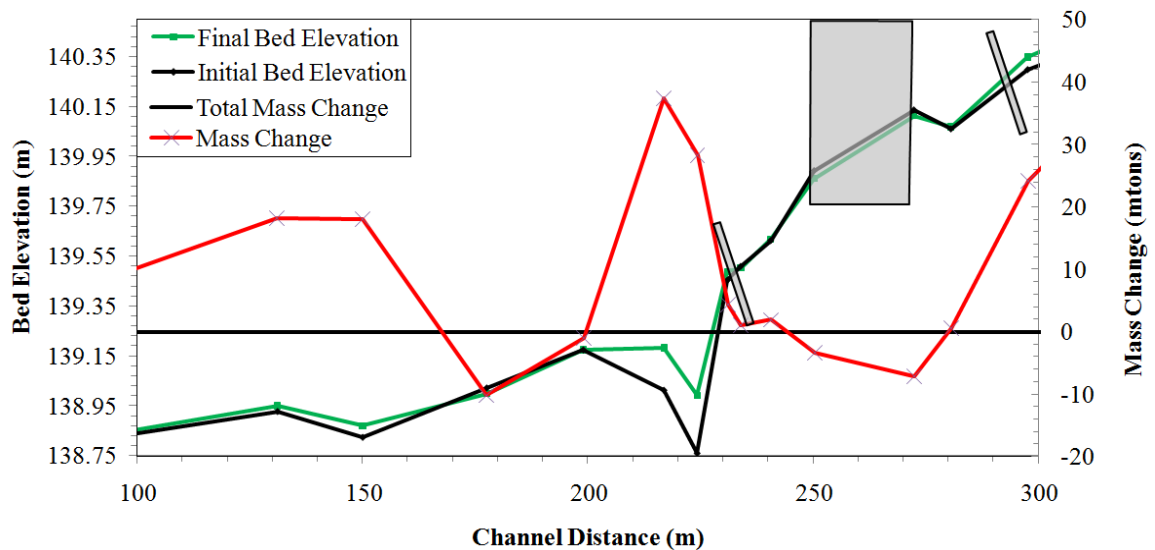
Figure 49 – Plot showing the change in the bed profile after the October 1, 2010 storm, and the total mass change at each section. Highlighted zones indicate the bridge and restoration structure locations.

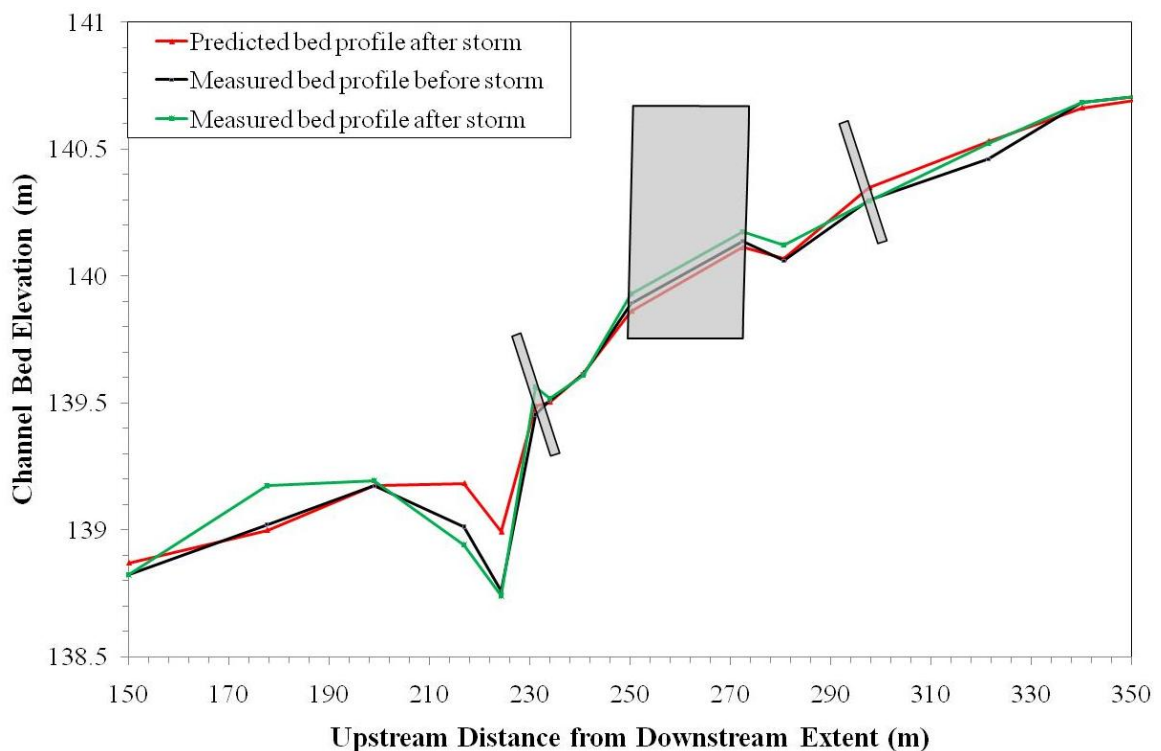
Figure 50 – Plot showing the measured bed elevations before and after the October 1, 2010 storm plotted against the HEC-RAS predicted bed elevation. Highlighted zones indicate the bridge and restoration structure locations.
