### Assessment of Stream Restoration Structures in Streams of North-Central Pennsylvania

Report to the Cora Brooks Foundation

# Assessment of stream restoration structures in streams of north-central Pennsylvania

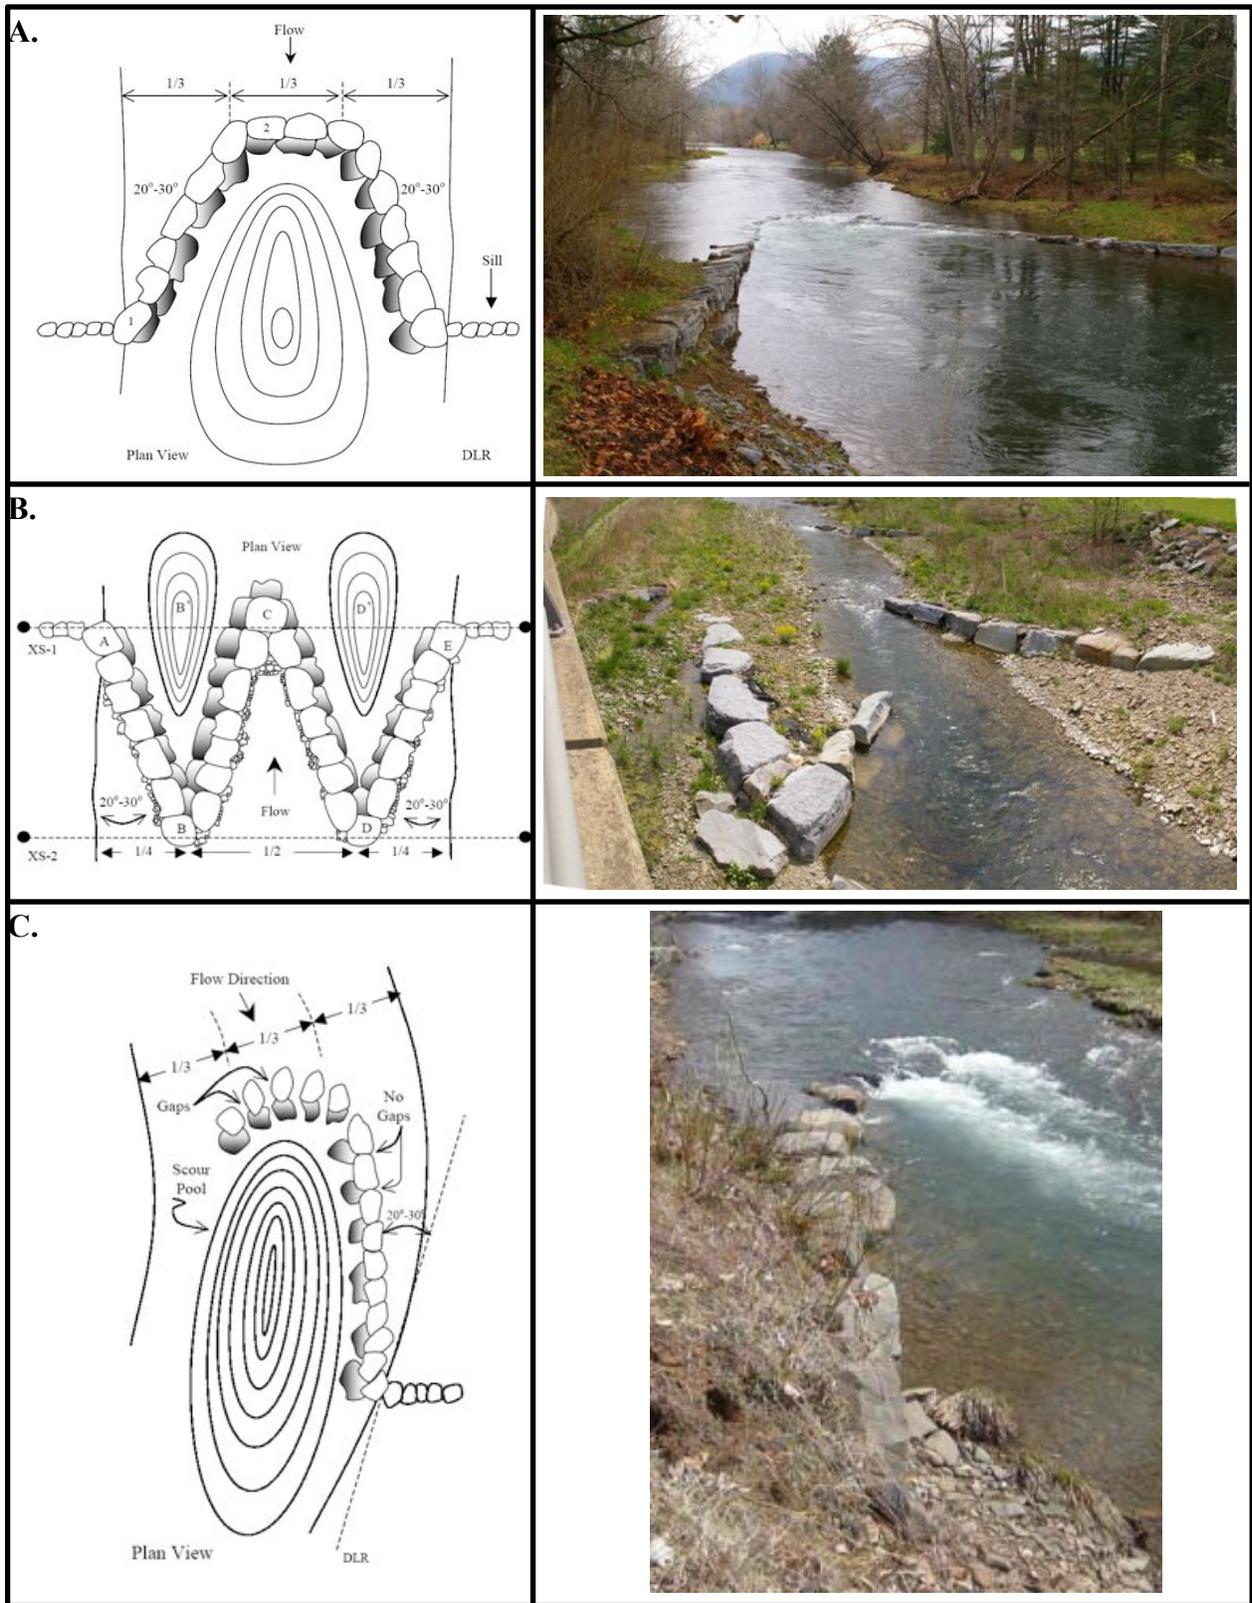
**Figure 1.** Sketches and photographs representing the types of structures used in stream restoration projects. A) Cross Vane. B) W-weir .C) J-hook. Sketches from Rosgen 2001. Photographs from C.Kassab and B. Hayes.

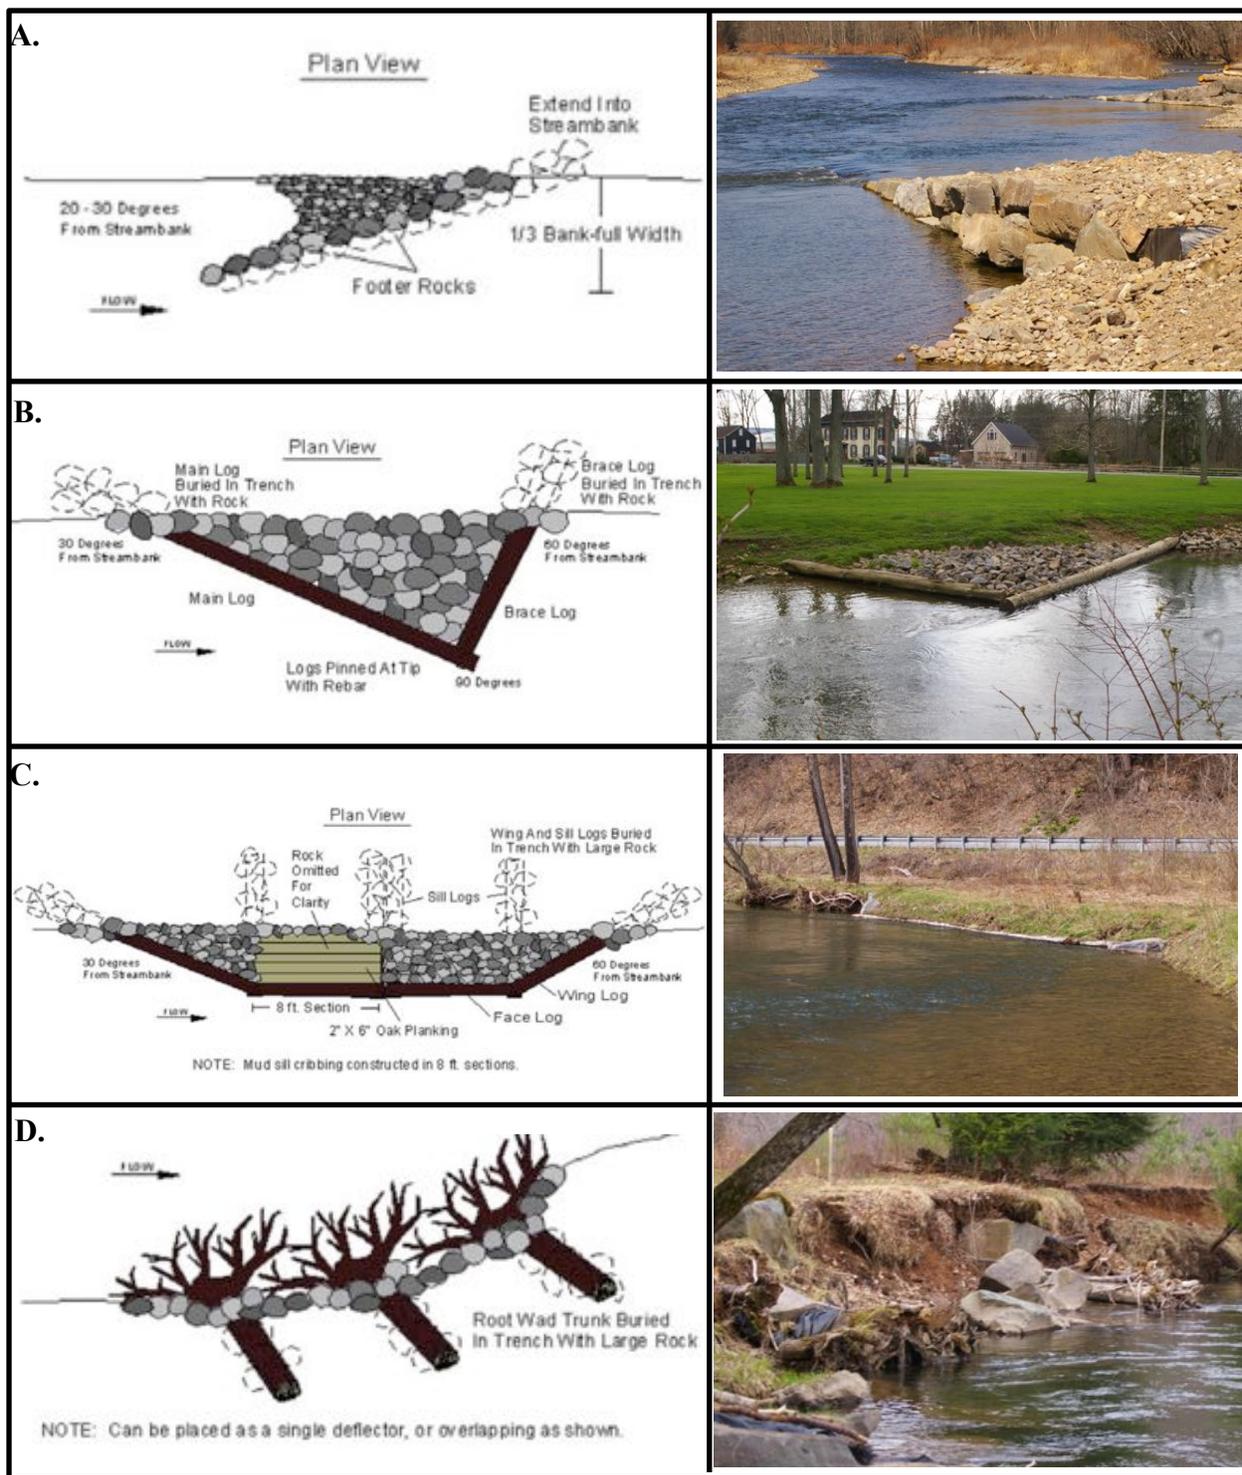
**Figure 2.** Sketches and photographs depicting the types of structures used in stream restoration projects. A) Rock Vane. B) Log deflector. C) Mudsill. D) Rootwads. Sketches are from Lutz 2007. Photographs by C. Kassab.
