Post-Flood Cleanup Alternatives Along Stream Corridors in Central Pennsylvania

Helping resolve river and land use conflicts in an economically and ecologically sustainable manner

A Scientific and River Engineering Perspective

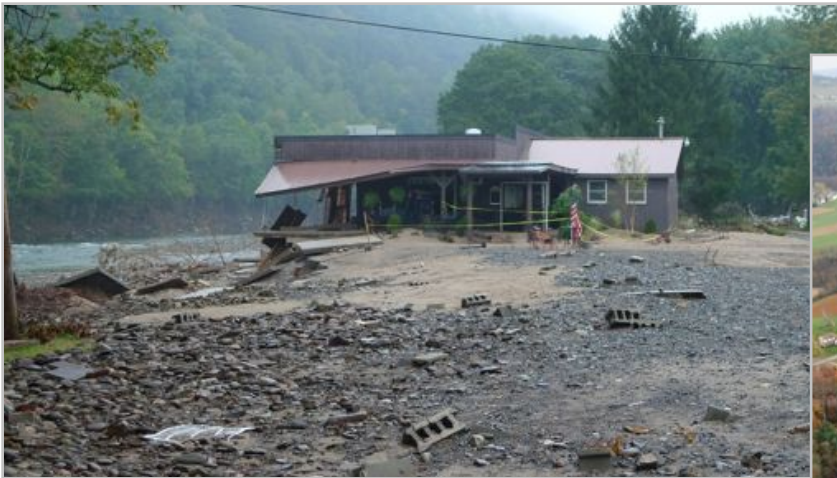
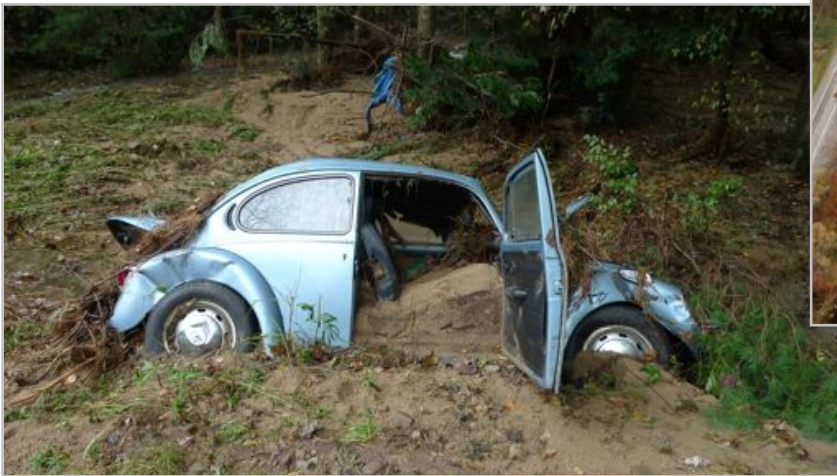
Tropical Storm Lee delivered over 18 inches of rain to steep, narrow watersheds in north-central Pennsylvania, devastating homes, roads, and bridges in the Muncy, Loyalsock, Fishing Creek and Lycoming creek watersheds.

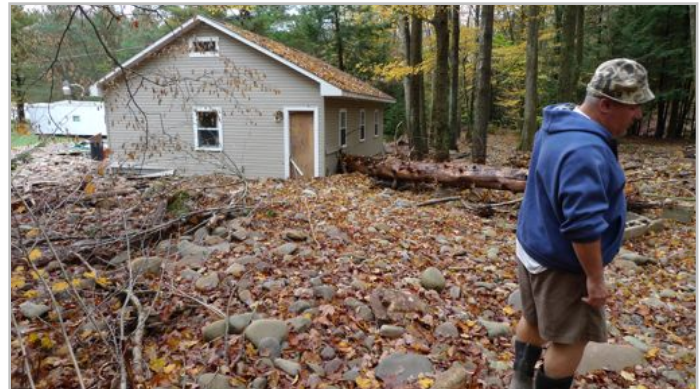
“ *They may be thinking only of protecting their property, but by digging out the gravel and widening the banks, they're just moving the problem to me and other homeowners.*

Now a head cut is working it's way upstream to my place, undermining my stream banks, washing more gravel downstream to fill in the hole they just created. I'm losing even more property.

- Quotes from a discussion with a resident whose home is located along Fishing Creek, regarding complications to his property after a downstream neighbor snagged, dredged, and realigned the stream following Tropical Storm Lee flood.
